## Ship-Platform Collisions in the North Sea

Helle A. Oltedal

**Keywords:** ship/platform collision, safety management, organizational causes, offshore vessel safety

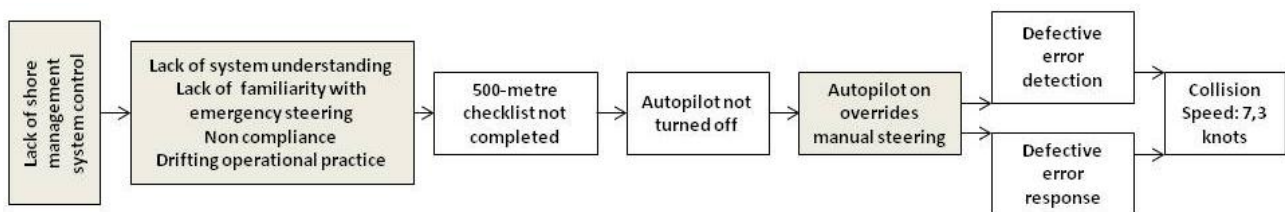
Figure 1. Course of event and causal factors in Case 1

**Case 1:** The incident took place during normal operations while approaching an installation. The captain and a second navigator were at the bridge. Within the installation's 500-metre security zone, the vessel is required to disengage the autopilot and switch to manual steering. In this case, the autopilot was not disengaged. The design of the autopilot overrides manual steering when the autopilot is on. Approximately

150 to 200 metres from the installation, the officer on watch tried to change course and reduce speed. As the autopilot was mistakenly left on, this manoeuvre resulted in an increased speed, from 4,4 knots to 7,3 knots, with the same heading against the installation. The bridge crew did not understand why the vessel did not respond as normal. One minute later, the vessel hit the installation. The investigation report identifies the autopilots on-modus as the direct cause of the incident. The 500-metre pre-entry checklist was signed as completed, but according to the investigation team, this could not have been done in an adequate manner as completion of the checklist would have detected the autopilot status. Thus, the underlying factor is linked to the violation of procedures. In addition, a lack of understanding of the autopilot system was pointed out, indicating that the error was not correctly identified. In this case, the navigators had not familiarized themselves with the emergency steering system, and their response to the situation was inadequate. It is also noted in the report that the particular crew on board had a record of a poor safety culture, and deviations were presumed to be normal practice on board (labelled as drifting operational practice in this study). The proposed safety measures developed in wake of the incident were all directed towards local and vessel-specific problems related to the incidents—namely, altering the auto pilot design and the checklist for entering 500-metre zones. The report did not identify any elements addressing the overall system in the company’s management. The course of the event and causal factors of the incident are depicted in Figure 1.

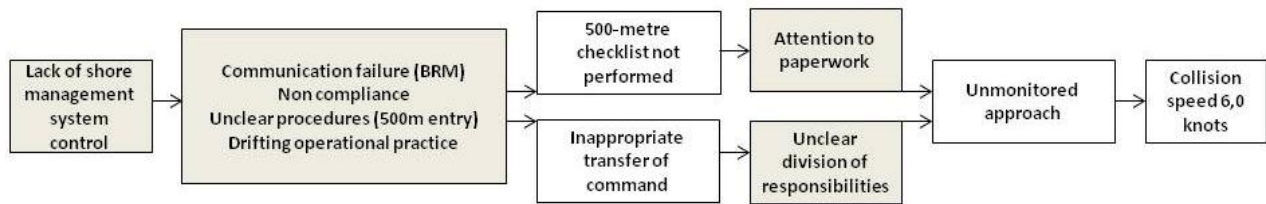
Figure 2. Course of event and causal factors in Case 2

**Case 2:** The incident happened while approaching the installation in heavy fog. The visibility was approximately 100 to 150 metres. The vessel’s captain, a second navigator and a lookout were at the bridge. Confusion related to who was in command led to the incident. The captain arrived at the bridge approximately 20 minutes before the incident, but did not take command formally or familiarize himself with the vessel’s position. The captain understood the second navigator to be in command, but the second navigator assumed that the captain was in command. Approximately 5 minutes before the impact, the captain received a VHF call concerning the transference of a passenger. Meanwhile, the second navigator went aft at the bridge to prepare the paperwork for loading. The second navigator was not explicitly told to start preparing the loading papers; it was more of a “comprehension” that this should be done. Due to unclear company instructions, the 500-metre pre-entry checklist had not been followed as required. According to the requirement, no paperwork is to be done within the 500-meter zone. As the second navigator was aft at the bridge, the captain moved forward towards the steering apparatus to check the vessel’s position. However, he was interrupted by the lookout’s warning that a riser had been observed. After detecting the situation, the captain’s response was correct, but the collision was inevitable. The vessel hit the installation at a speed of 6,0 knots. Identified causes of the incident include poor communication in the transfer of command, non-compliance of procedures and unclear procedures. Several of the company checklists and instructions were violated, and the investigators indicated that the officers had a relaxed attitude towards procedures and guidelines. Thus, deviations from standards were assumed to be normal practice on board the vessel. The shipping company was recommended to offer the Bridge Recourse Management (BRM) course to their officers. In addition, all checklists onboard the particular vessel were to be revisited, not only those relevant for the particular incident. The report also noted that the crew expressed that the onboard workload was heavy during certain periods; however, this and other safety conditions related to shore management activities were not addressed in the safety recommendation. The course of the event and causal factors of the incident are depicted in Figure 2.

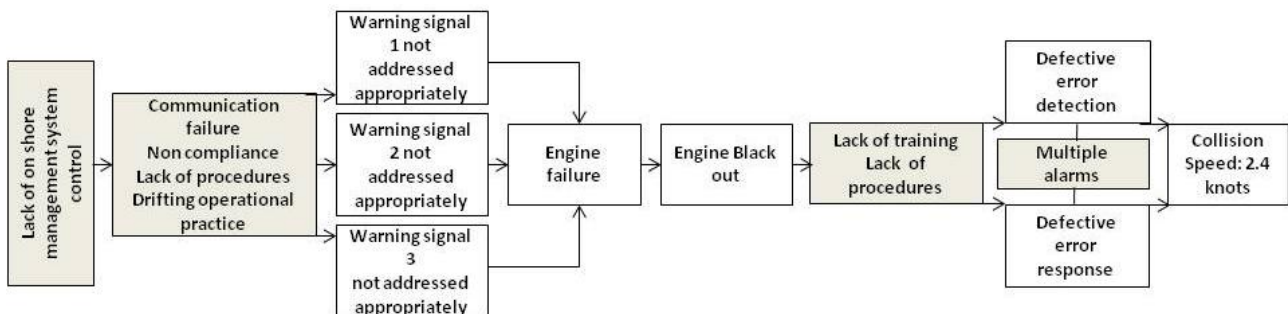
Figure 3. Course of event and causal factors in Case 3

**Case 3:** While preparing to load, the vessel suffered a blackout due to engine failure. At least three early warning signals were ignored and not handled in accordance with procedures and/or best practices. First, three days prior to the incident, the crew experienced related engine problems which were handled inadequately, but in accordance with shipboard practices. Second, a second engine problem was experienced before arriving in the oil field; neither the engine problem nor the crew's responsive action, which were not according to best practices, was reported to the chief engineer. Finally, a third warning was given the day before the incident, when the vessel suffered another blackout. With reference to the actual incident, the bridge team's response to the blackout indicated deficient error detection and error response due to a lack of knowledge and training related to the Dynamic Position (DP) position reference system. With reference to error detection and response, the stress induced by massive visual and multiple alarms along with safety concern for exposed crew was determined to be contributory factors. At the time, relevant emergency procedures were lacking. Thus, underlying causes included the lack of procedures, violation of procedures and improper operational practice, poor communication among engine crew members, and early warnings/faults not being dealt with properly. The investigation revealed that some of the crewmembers expressed concern regarding the onboard work environment, especially the heavy workload and large amount of administrative work required. The crew's concerns were not addressed in preventive measures. Recommended corrective actions address the specific identified causes of the incident rather than the overall management system. The course of the event and causal factors of the incident are depicted in Figure 3.

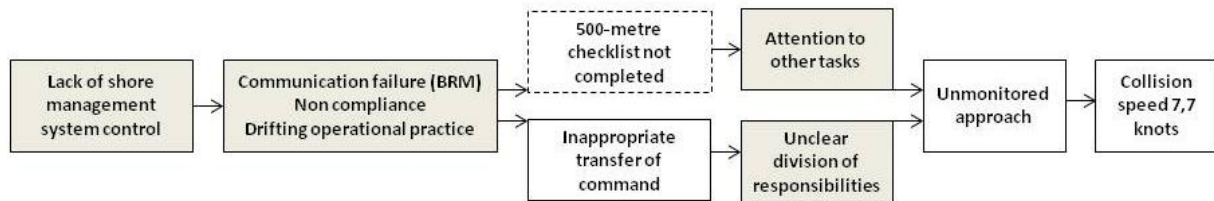
Figure 4. Course of event and causal factors in Case 4

**Case 4:** The incident took place during normal operations approaching the installation. At the time of the incident, the vessel's captain and a second navigator were present on the bridge. Confusion related to who was in command resulted in the incident. After arriving on the bridge shortly before the incident, the captain did not formally take command by giving this verbal order to the navigator. On board, it was normal practice for the captain to automatically take command when on the bridge, which is a breach of formal operating procedures. The second navigator was commanded by the captain to start preparing the vessel for loading, and the second navigator accordingly left the position for manoeuvring the vessel. Then, during the approach to the installation, the captain also left the forward operating position unattended, leaving the approach to the installation unmonitored for approximately one minute, resulting in a collision with the installation at a speed of 7,7 knots. The captain left his position without verifying the vessel's position, speed, heading or distance from the installation. The major influencing factors in the incident seemed to be poor communication among the members of the bridge team and unclear division of responsibilities. Such a bridge team arrangement is a violation of both the shipping company's procedures and NWEA guidelines for the Norwegian Continental Shelf. The 500-metre checklist for pre-entry was not completed; however, it is uncertain whether completion of the checklist would prevent the incident. The investigation report put forward that a culture of poor compliance with existing procedures seemed to exist. For example, the report states that the formal

transference of command was never practiced on board. Thus, normal operational practice had drifted from the formal standardized rules. The investigation found that the company's safety management department was undermanned in relation to the size of the company fleet; however, specific safety measures or requirements for this circumstance were not given. The company had previously experienced near-miss incidents involving a lack of navigation watches and misunderstandings about bridge responsibilities; however, the internal learning process was apparently weak. In this case, the investigation report explicitly addresses several weaknesses in the company's overall safety management system, which is also addressed in the recommended measurements. The course of the event and causal factors of the incident are depicted in Figure 4.

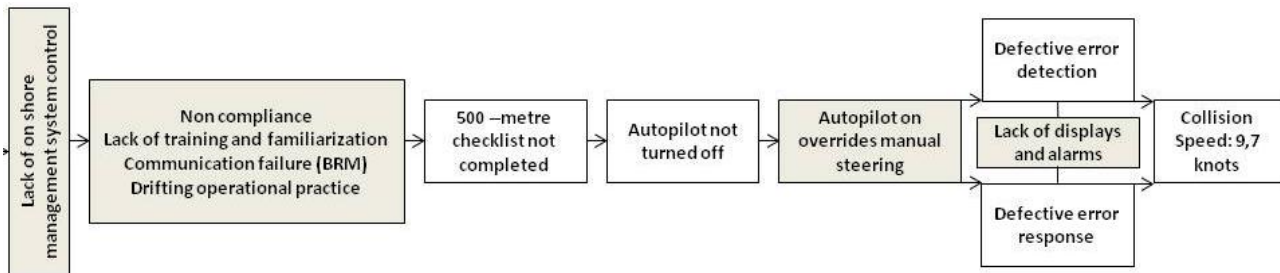
Figure 5. Course of event and causal factors in Case 5

**Case 5:** When approaching the installation, after taking command on the bridge, the captain received a telephone call from the charter's representative in relation to entry permission. When answering the phone, instead of leaving the steering control to the second navigator, the captain switched over from manual steering to autopilot. He subsequently forgot to switch the autopilot off, which resulted in him not being able to override the autopilot, and the speed increased towards the installation. When entering the 500-metre zone, the pre-entry checklist was not completed, although it was signed as completed. In addition, the DP test was not performed, and the autopilot was not switched off. The situation with the autopilot overriding the manual steering was not identified by the captain or the second navigator. The captain assumed that the situation had been caused by a technical issue. The investigation report identifies a lack of installed autopilot or manoeuvring alarms as a contributory factor. From the time the captain realized that he did not have the expected manual control until the time of the collision—approximately three minutes later—both the captain and second navigator failed to activate the emergency stop, turn off the autopilot or use the emergency steering. Thus, the error response was also defective. The report noted that no effort was made by the second navigator to intervene or assist the captain. The second officer had been on board five days and had not received the required familiarization training or vessel-specific DP training, which is also in breach of the requirements, as within the 500-metre zone, the bridge should be manned by two navigators and the co-navigator should be capable of taking over the vessel if required. However, given that the second navigator had not been fully trained for such tasks, this requirement cannot be considered to have been fully completed. The report also notes that, on board, it seems to be a lack of respect for procedures in general; thus, it is assumed that the violation of procedures was normal operational practice on board, and several standards were violated. For example, although it was not a contributory factor in this case, the crew stated that it was not a practice to conduct emergency exercises, including breakdowns of the bridge operation system. Inadequate bridge team management practices were found to be among the most contributory factors (e.g., improper bridge team communication and hand-over practices). Recommended safety measures addressing incident-specific areas included improvement of bridge team management and familiarization with emergency response procedures. However, the report did not question if these weaknesses derived from underlying system deficiencies. For example, if there is an underlying system management deficiency, similar weaknesses could be a problem in other operational areas or vessel departments as well. The course of the event and causal factors of the incident are depicted in Figure 5.

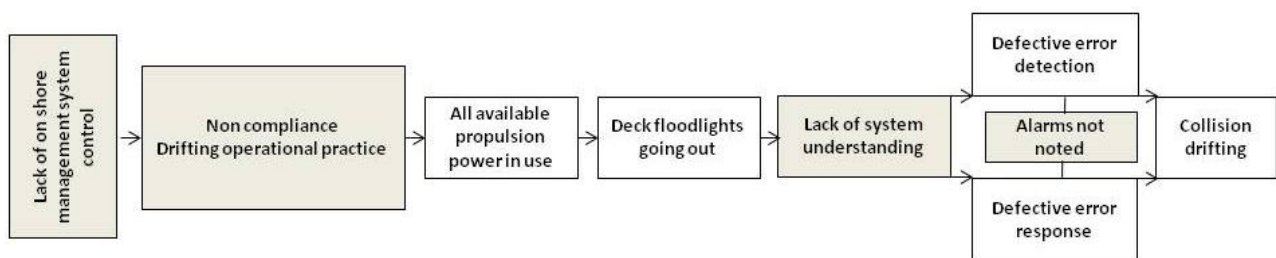
Figure 6. Course of event and causal factors in Case 6

**Case 6:** The incident took place during the loading operation. Three navigators were present on the bridge. Due to technical failure with one of the installation’s cranes, the vessel manoeuvred from the leeside of the installation to the weather side. When moving the vessel, the captain used all available propulsion power for a longer period than normal, causing the deck lights to go out. At this point, the captain did not see the red main engine overload alarm, and he has no recollection of an audible alarm. The captain perceived the darkening of the deck lights as a power supply loss and zeroed the pitch controls on his main propellers; shortly thereafter, the vessel hit the installation. The captain’s interpretation of the situation indicated a lack of understanding of the power distribution in high-load conditions. In the investigation report, four main causes related to the vessel were revealed: lack of awareness and use of relevant procedures and guidelines, decision of manoeuvring of vessel to the weather side, decision of manoeuvring too close to the rig and incorrect interpretation of the deck flood lights going out. The investigation team traced the non-utilization of procedures and guidelines back to previous similar episodes of non-compliance, providing a level of legitimacy for not using relevant procedures. Thus, non-compliance seemed to be normal operational practice. Non-compliance to procedures was partly linked to the insufficient management of change when the North West European Area (NWEA) guidelines replaced previous operational guidelines. This, along with poor communication of the practical implication of the changes, related to the technical redundancy requirements for vessels working on the weather side. When linking human error and operational practice to the development and implementation of national requirements, this case dug deeper than the others in search of a root cause. Improvements related to the NWEA guidelines are also reflected in the final recommendations. Recommendations reflected towards the crew include implementation of Bridge Team Management Training and the need to carry out a safety culture survey. The course of the event and causal factors of the incident are depicted in Figure 6.
