# Groundwater fluctuations during a debris flow event in western Norway – triggered by rain and snowmelt

Stein Bondevik<sup>1</sup> and Asgeir Sorteberg<sup>2</sup>

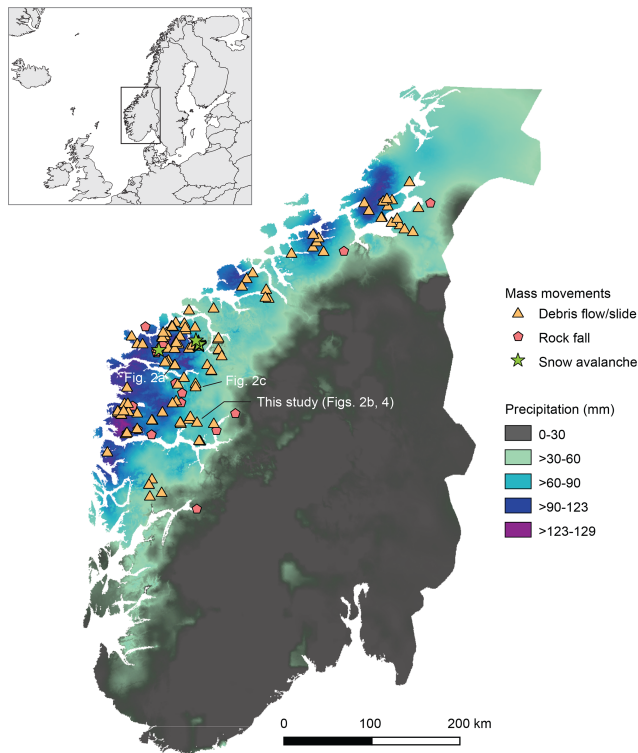
**Figure 1.** Mass movements that occurred on 15 and 16 November 2013 during storm Hilde in Norway – 114 debris flows and slides, 28 rockfalls, and 7 snow avalanches. Data retrieved from the Norwegian landslide database: <https://gis3.nve.no/link/?link=SkredHendelser> (last access: 25 January 2019). Precipitation is interpolated from observations and shows the amount in millimeters (mm) in 24 h, collected at 06:00 UTC 16 November (07:00 LT, local time); data were retrieved from <http://www.xgeo.no/> (last access: 21 March 2019).

itation map in Fig. 1 and wrote the first draft of Sect. 5.3 “Future changes in precipitation and snowmelt”.

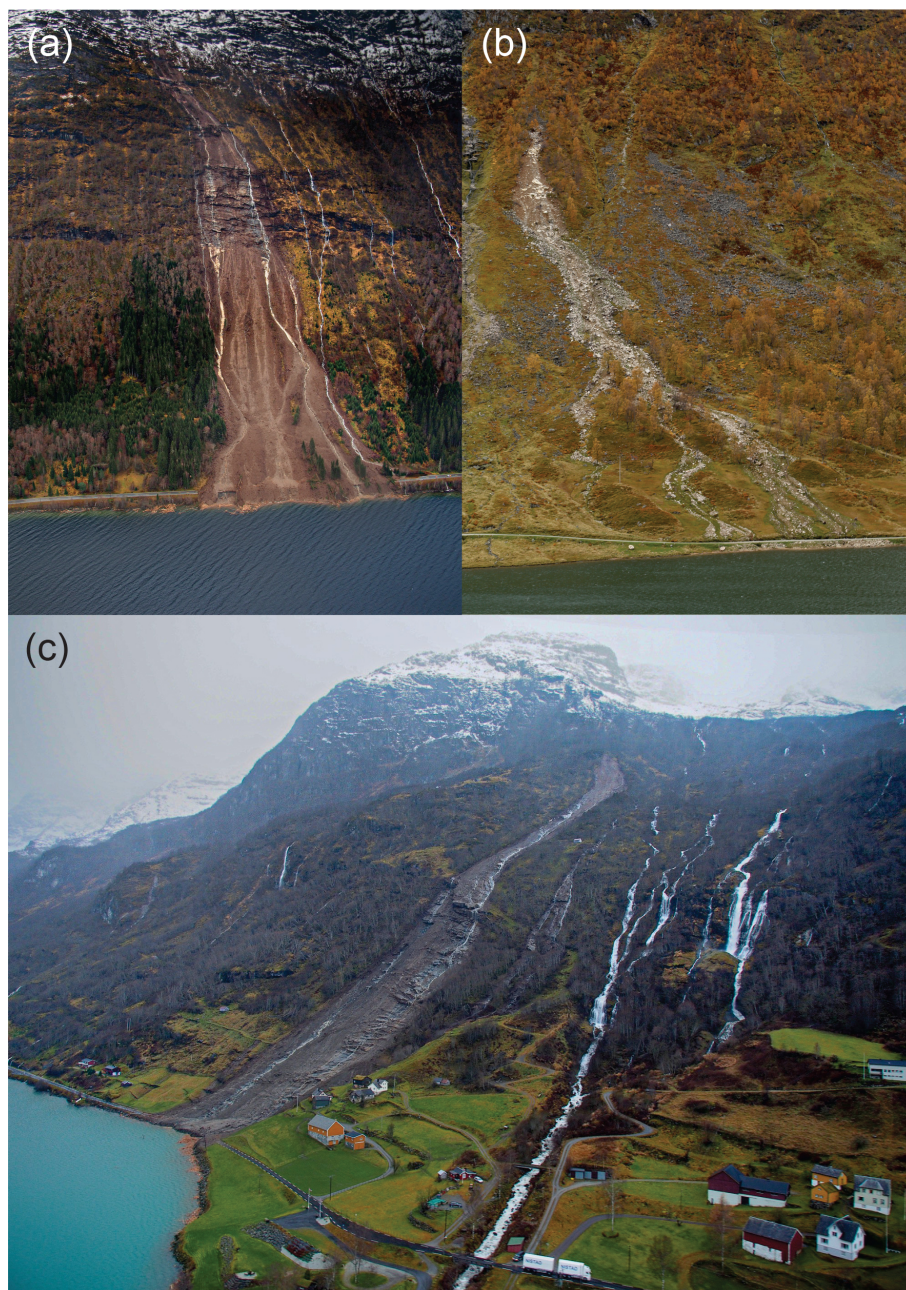
**Figure 2.** Photos of landslides that occurred during storm Hilde in 2013; see Table 1 for details. (a) Skredestranda, photo: Jan Helge Aalbu, 16 November 2013. (b) Anestølen, this study, photo: Kevin Saurin, 6 October 2014. (c) Oldedalen at Yri, photo: Jan Helge Aalbu, 16 November 2013.

**Table 1.** Information of the landslides shown in Fig. 2a, b and c.

Figure	Location	Date	Time (hour, LT)	Top altitude	End altitude	Length of slide	Mean slope	Comment
2a	Skredestranda, south of lake Hornindalsvatnet, Nordfjord.	15 Nov	21–22	620 m	53 m	830 m	34°	The landslide continued into lake Hornindalsvatnet (53 m altitude) and covered 250 m of the road. Road was closed for several days. Triggered small tsunami <1 m (Søgne-sand, 2018; Nve, 2021).
2b	Anestølen, Sogndal – this study.	15 Nov	~ 19–23	700 m	439 m	550 m	25°	See details in this paper.
2c	Oldedalen, Yri, Nordfjord.	15 Nov	~ 23	480 m	33 m	780 m	30°	The largest of three slides that occurred around lake Oldevatnet (33 m altitude). Damaged road and took out electricity. Triggered tsunami in the lake (Nve, 2021).

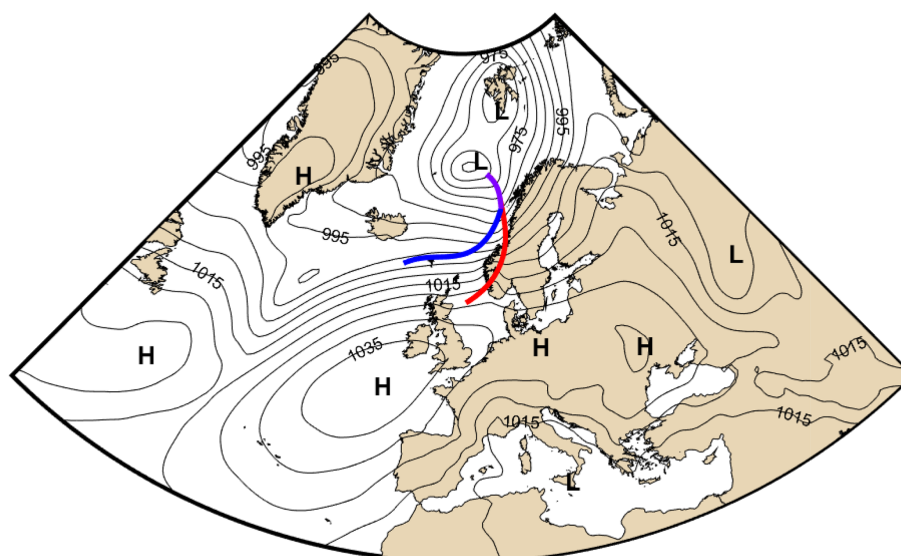
**Figure 3.** Mean sea level pressure (hPa) on 15 November at 12:00 UTC (13:00 LT, local time). Large amounts of warm and moist air blew towards the Norwegian coast because of low pressure northeast of Iceland and high pressure southwest of England. The air was close to 100 % saturated with water vapor, which precipitated as the air cooled when it rose over the mountains in western Norway. The red line indicates the position of the warm front, and the blue line is the cold front. The warm air sector lies between the red and blue lines. The purple line indicates an occluded front, which means that the cold front has caught up with the warm front.

The storm was a classic extreme precipitation event on the west coast of Norway. A warm mature front, partly occluded, passed southern Norway on 15 November. The pressure configuration, with a very low-pressure system northeast of Iceland and a high-pressure center southwest of the UK, generated a strong north–south pressure gradient and induced a southwesterly flow of moist warm air towards western Norway (Fig. 3). It rained heavily as the moist air was lifted by the warm front. The precipitation further intensified as the

flow ascended over the mountains of western Norway. This weather situation leads to the formation of narrow plumes of intense high-level moisture, often referred to as atmospheric rivers. These cause most of the extreme precipitation events on the west coast of Norway (Azad and Sorteberg, 2017).

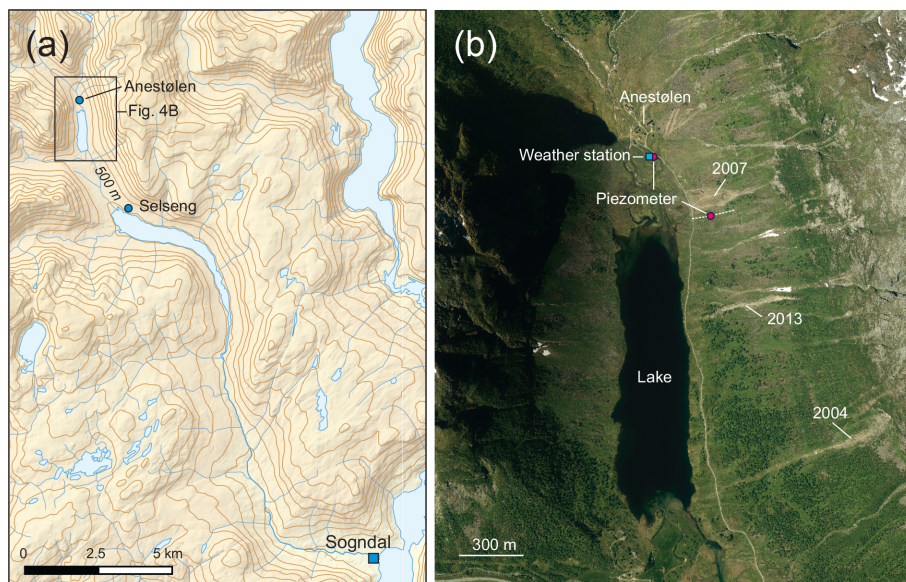
**Figure 4.** Map and aerial photo from 2018 of the site near Anestølen. (a) The contour interval is 100 m. (b) The eastern slope is prone to debris slides and flows, and the most recent landslides are indicated with the year they occurred. There is a weather station including a piezometer located in the valley bottom (station no. 77.24.0) (<https://sildre.nve.no>, last access: 6 February 2019). We installed a piezometer in a borehole on the hillslope close to the southern slide scar of the 2007 slide. The dashed white line across the borehole shows the location of the profile in Fig. 5a © Kartverket/Geovekst (<https://www.kartverket.no/>, last access: 4 January 2020).

The hillside we instrumented is typical of western Norway and is prone to debris flows and shallow slides. The hillside is near Sogndal, east of the lake at Anestølen (Fig. 4). Recent slide events on this slope occurred on 18 May 2004, 22 September 2007 (Tyssebotn and Velle, 2010) and 15 November 2013 (Olsen et al., 2015) (Fig. 4b). The lower part of the slope is covered by slide deposits and till, and the average slope angle is 25–26°. The sediment-covered slope tapers off upwards into steeper and exposed bedrock and cliffs (Fig. 5a). From the outcrops of the slide scar of the 2007 slide event (Fig. 4b), we found that the thickness of the deposits on the slope varies, probably between 2 and 5 m.

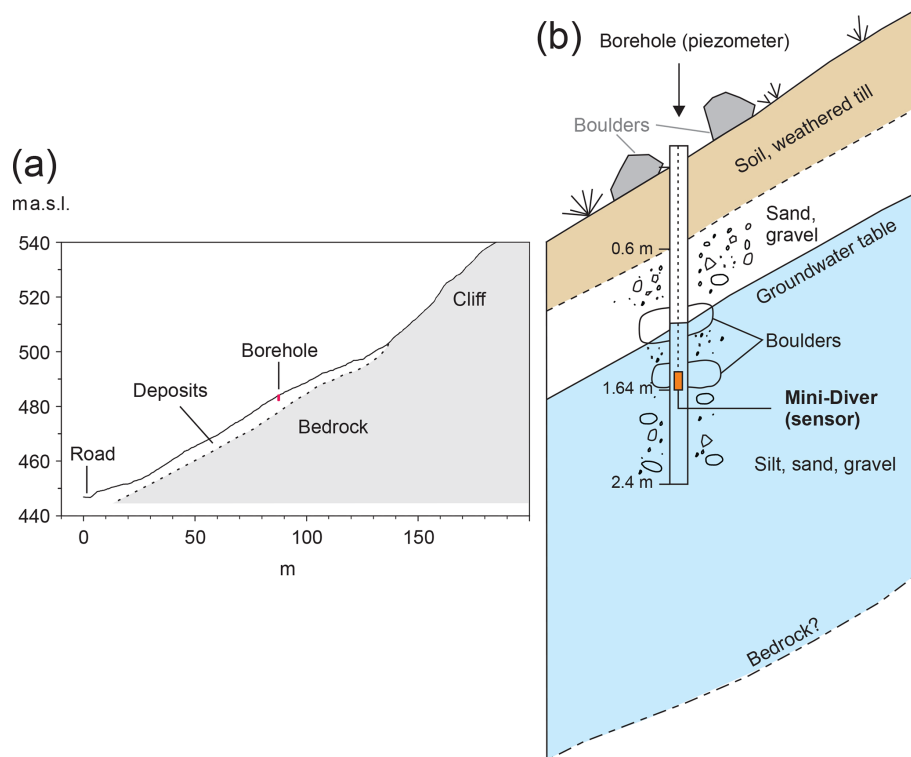
**Figure 5.** Profile of the hillside just south of the southern slide scar of the 2007 landslide (Fig. 4b), showing the borehole with the instrumented piezometer. **(a)** Average steepness of the sediment-covered slope is 25–26°. The dashed line indicates where we believe the boundary between till and bedrock is located, based on observations from the 2007 slide scar (Fig. 4b). **(b)** The Mini-Diver (sensor) is suspended from a wire in the piezometer and anchored 1.64 m below the surface. The top 60 cm of deposits consists of organic soil and weathered till, with firm till below that. We drilled through boulders at depths of ca. 1 and 1.5 m.

We drilled through boulders and relatively firm deposits down to 2.4 m below the surface using a hammer drill powered by compressed air (Fig. 5b). The borehole is located near the 2007 landslide, 40 m south of the slide scar and about 200 m upslope from the toe of the landslide, at an altitude of 484 m. We pushed and hammered threaded pipes, 1 m long and 32 mm in diameter, down into the borehole. The pipes were subsequently screwed together. The lower pipe (piezometer) has 12 slits, 10 cm long and 2 mm in width, to allow for water seepage. The data logger, a Mini-Diver (DI 501) manufactured by Van Essen Instruments, was attached to a wire and inserted into the pipe. The lower end of the Mini-Diver is at 1.64 m below the ground surface (Fig. 5b). The drilling and instrumentation are described in Tyssebotn and Velle (2010).

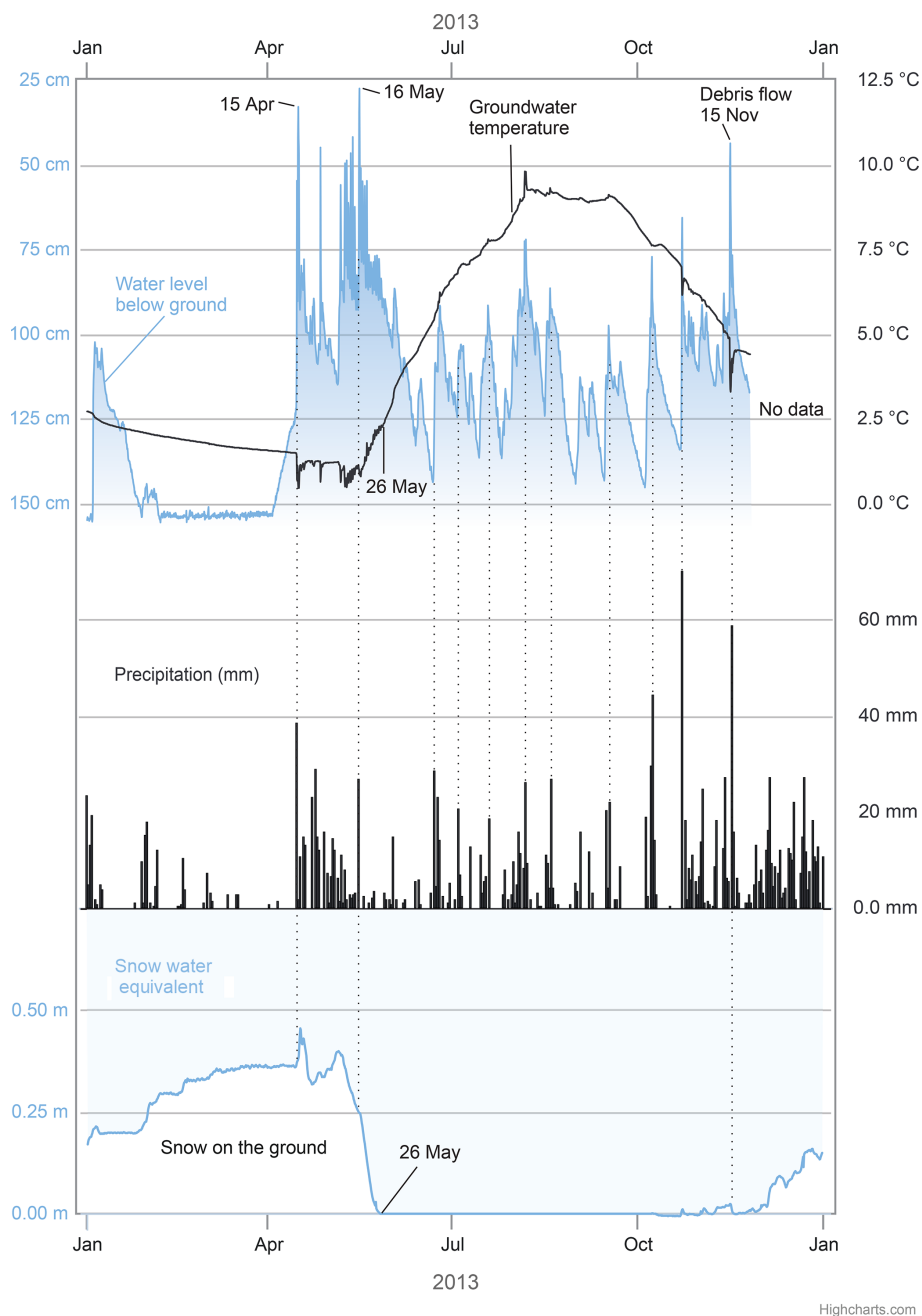
**Figure 6.** The upper diagram shows groundwater level (blue curve) and groundwater temperature (black curve) from the borehole on the slope in 2013. The middle diagram shows 24 h precipitation at the weather station at Selseng (Fig. 4a) (station no. 55700, <http://eklima.met.no>, last access: 4 February 2019). The lower diagram shows the snow water equivalent measured with a snow pillow at the weather station 77.24.0 (Fig. 4b). The small wiggles in the temperature curve end on 26 May – the same day the snow pillow was free of snow. One of the most pronounced oscillations is on 15–16 November, when a debris flow occurred on this hillslope.

Groundwater temperatures follow the season but show small, irregular oscillations that reflect infiltration episodes. The temperature curves (Figs. 6, S7–S9) show a steady, slow decline through the winter to about 1.5–2 °C and an abrupt drop in the spring when temperature reaches its minimum (0.5–1.2 °C), with wiggles in the temperature curve reflecting meltwater reaching the sensor, followed by a large rise from May to August up to 9.5–10 °C. In September the groundwater temperatures start a steady decline towards the winter minimum. However, the temperature curves show a number of small anomalies that coincide with peaks in groundwater level. These anomalies are caused by infiltration of surface water that is either colder or warmer than the groundwater. Infiltration episodes between October and May cause the temperature to drop; the largest observed were drops of 1.5 and 1.8 °C related to snowmelt (Figs. 6, S8). Between May and October, surface water is warmer than the groundwater; infiltration episodes cause temperature rises, with the largest recorded being about 1 °C and associated with summer rain events in July (Fig. S8) and August (Fig. 6).

The substantial drop in groundwater temperature suggests that part of the infiltration was from snowmelt. There was already some snow on the ground on 15 November (Fig. 6), and the precipitation in the morning and until about 15:00 fell as snow because of the low air temperature (Fig. 8). During this time there was no response in the groundwater level or temperature. However, after 15:00, when the warm, moist air of the storm reached Anestølen, the groundwater rose by 9.5 cm/h, and at the same time, the temperature of the groundwater dropped by 0.2 °C/h. The rapid snowmelt added extra water to the slope and augmented the infiltration rate and groundwater rise, as seen from rainfall on snow on slopes in Alaska (Sidle, 1984).

Melting of the snow cover in combination with rain leads to high groundwater levels. In 2013 we recorded the year's highest peaks in April and May (Fig. 6), when the ground was partly frozen and still covered by snow (Fig. 6). The high peaks correspond to lows in the groundwater temperature curve, reflecting the infiltration of cold meltwater. The highest peaks were on 15 April and 16 May (33 and 28 cm below the ground, respectively) and coincided with rain (Fig. 6), high air temperatures (>8°C) (Fig. S1) and thawing of the frozen soil. This high groundwater level did not cause any

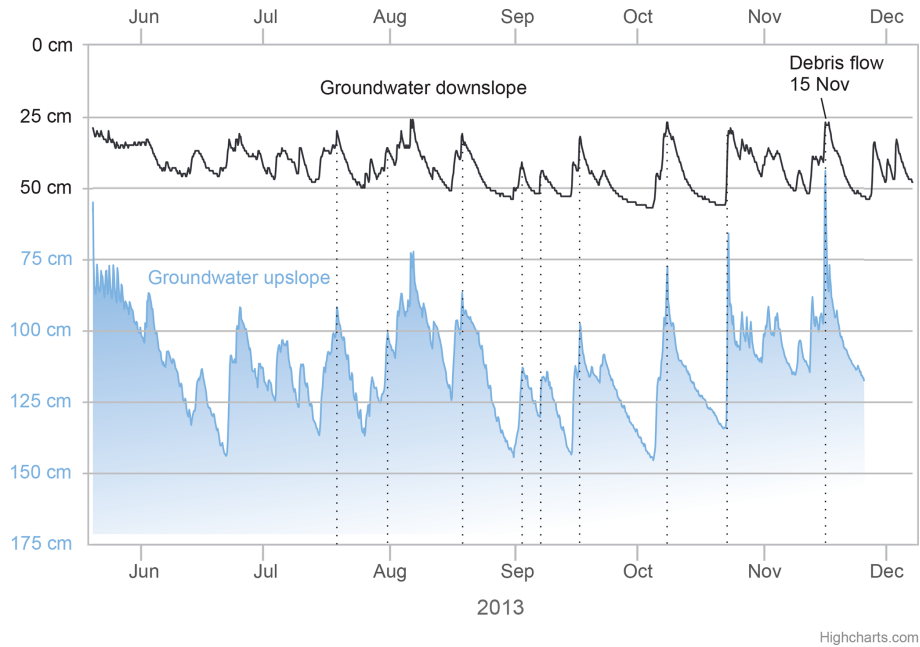
**Figure 7.** Groundwater fluctuations in June–December 2013. The upper curve (black) shows fluctuations at the weather station in the valley bottom. The blue curve shows the fluctuations in the borehole upslope. The minima and maxima occur at the same time (dotted lines), but the peaks upslope are sharper, last less than 4 h and have higher amplitudes, and the individual peaks reach different levels. The ground in the valley bottom is saturated at a registered depth of around 25 cm.

The groundwater level on the slope varies according to season and precipitation. In winter the groundwater table is low, and in 2013 the water level was below the sensor in February and March, apparently because the ground was frozen (e.g., Ireson et al., 2013) (Fig. 6). During spring, from April to June, the groundwater is recharged by snowmelt, rain and thawing of the frozen ground (Du et al., 2019), which cause high peaks and rapid changes. In summer and fall, the groundwater level is controlled by precipitation events and normally oscillates between 150 and 75 cm below the ground (Figs. 6, S7–S9). A few times in the summer, the groundwater level is lower than the sensor. Most of the oscillations show a rapid, almost instantaneous, rise and a longer, slower, decline – the oscillations are clearly asymmetric (Fig. 7).

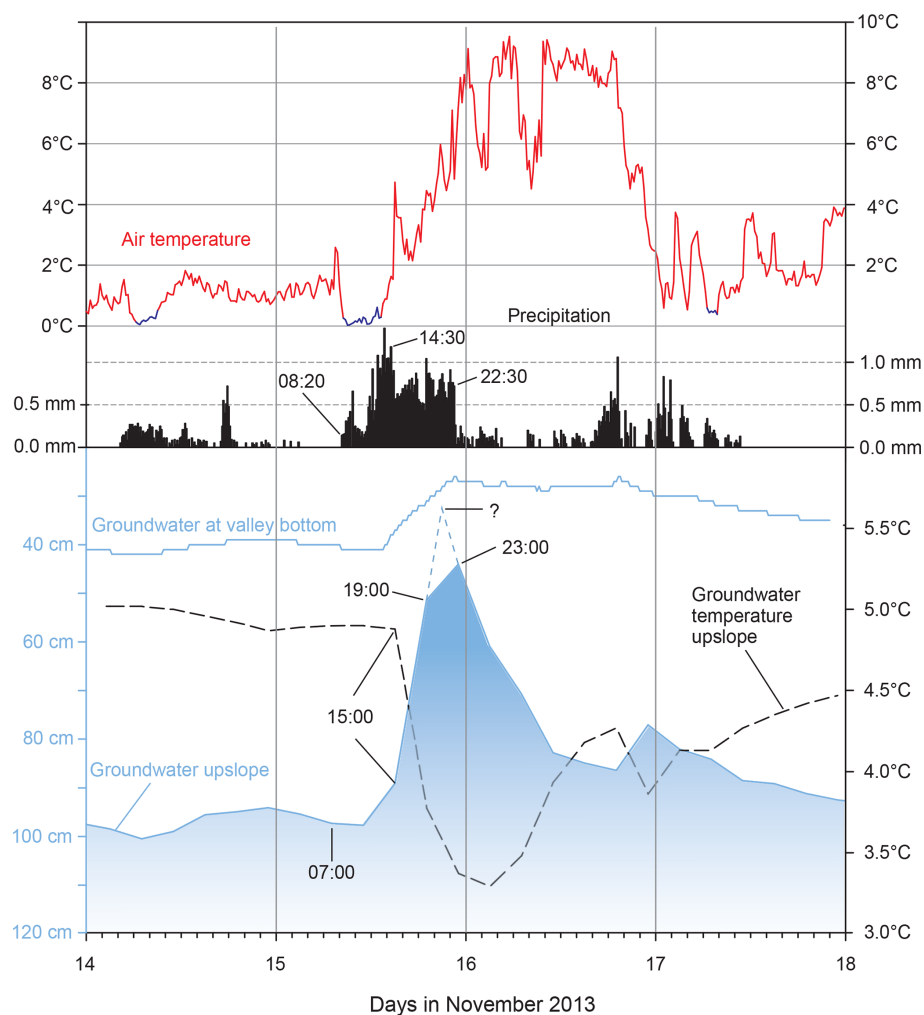
**Figure 8.** Air temperatures, precipitation and groundwater between 14 and 18 November 2013. The upper diagram shows air temperature (red curve) and precipitation in millimeters (mm) every 10 min. The lower diagram shows the groundwater level and groundwater temperature. Blue segments of the air temperature curve show periods when the temperature is close to 0°C. Groundwater probably reached its highest level between 19:00 and 23:00, shown as a dotted line and a question mark.

after reaching peak levels, while the valley bottom peaks last for half a day or more (Fig. 8).

Hilde (Fig. 8), and this is an order of magnitude larger than the total amount of rainfall and snow (53 mm). A similar relationship has been found in other studies (e.g., Sidle, 1984).

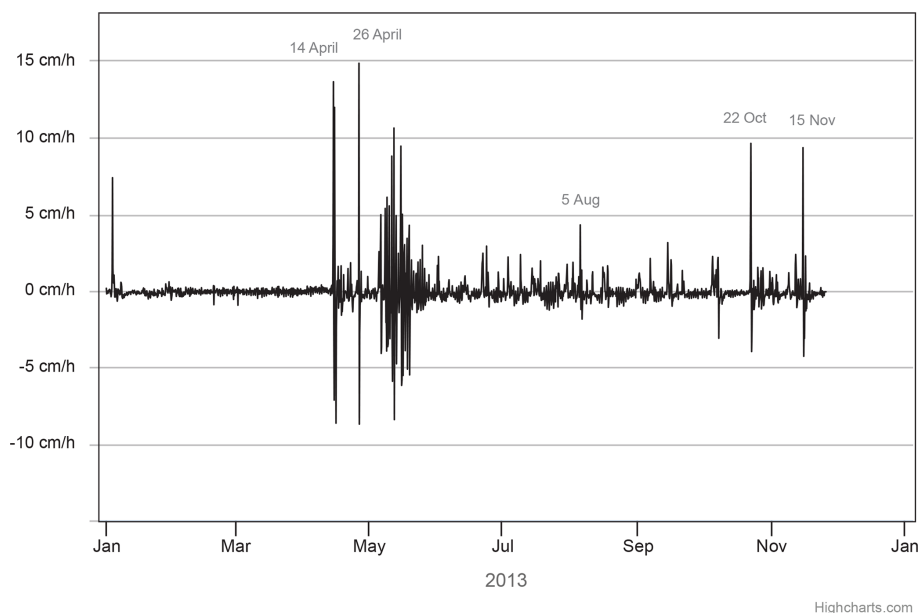
**Figure 9.** Rates of change of the groundwater level upslope in 2013. The highest rates are in April and May and are caused by melting of the snow cover and thawing of the ground.

4 years of recordings (Figs. 9, S10–S12). Nevertheless, no landslide was observed, because the groundwater level was too low when the rain started, and the peak did not reach higher than 97 cm below the surface. This shows that it is not the rise itself but the level that the groundwater reaches that is important.

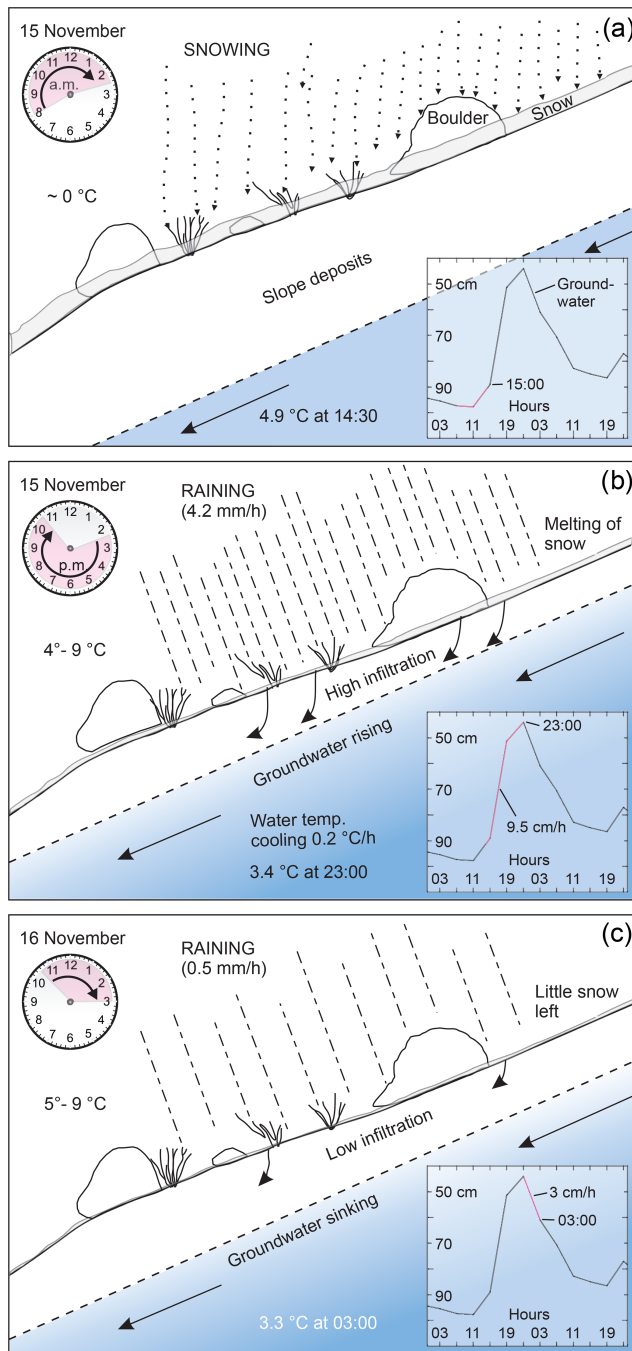
**Figure 10.** Diagrams to explain the situation on the hillslope during storm Hilde on 15–16 November 2013. The purple section of the clock and purple segment of the groundwater curve in the graph in the lower right corner show the time. (a) Between 08:00 and 14:30, air temperatures were close to 0 °C, and the precipitation fell as snow. Groundwater level was stable (graph in lower right corner). (b) Between 14:30 and 22:30, the air temperature rose to 9 °C, it rained 4.2 mm/h, groundwater level rose by 9.5 cm/h and groundwater temperatures dropped by 1.6 °C. (c) After 22:30, the heavy rain ceased, and the groundwater dropped by 3 cm/h.

The groundwater level in the hillslope continued to rise as long as the infiltration rate was higher than the downslope discharge of groundwater (Fig. 10, middle panel). The heavy rain ceased at 22:30, and after 23:00 the groundwater level fell by 3 cm/h (Fig. 10, lower panel). The groundwater level was still rising just after 19:00, so the peak, when groundwater was less than 50 cm from the surface, must have been shorter than 4 h. Such a short peak suggests that very little groundwater from higher up the slope or from bedrock fractures (Johnson and Sitar, 1990) could have contributed to the rise in groundwater level. The entire groundwater rise can be explained by vertical infiltration through the surface. The full amplitude of the groundwater peak was 54 cm during storm
