An Investigation of Cornice Development Control at Kvannberget, Norway

Master Thesis in Climate Change Management

Department of Environmental Sciences, Faculty of Engineering and Science

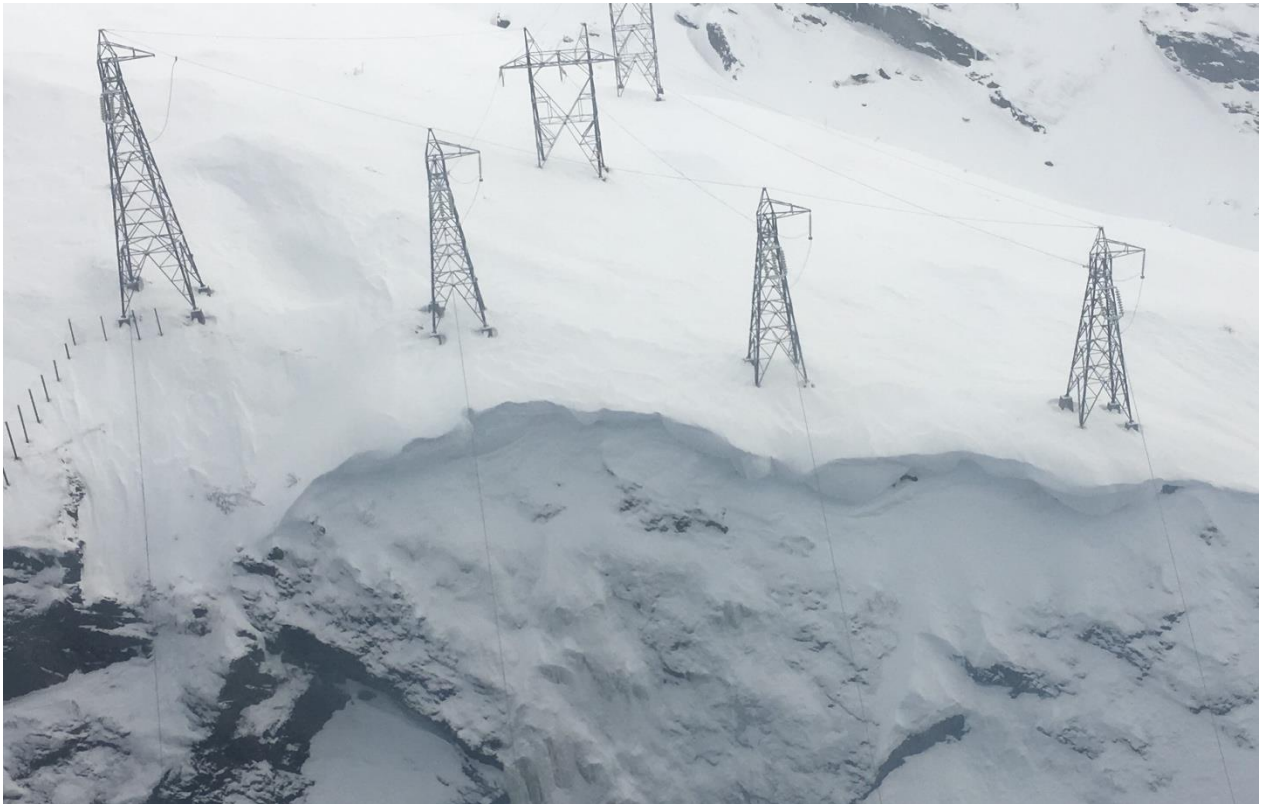
Figure 1-1: The horizontal extent of the cornice structure at Kvannberget has previously interfered with the power lines. Note the small depression at the lip of the cornice where the powerline from the second mast from the left was in contact with the snow. The image is from 2018.

Snow cornices are a natural hazard that put people and infrastructure at risk in mountainous areas. The West facing ridgeline at Kvannberget is prone to the development of a large, continuous cornice structure. Contrary to other locations, where cornice fall and resulting snow avalanches are the most pronounced threats posed by snow cornices (Montagne, McPartland, Super, & Townes, 1968), the problem at Kvannberget is connected to the horizontal extent of the cornice and the power lines coming in contact with the snow surface.

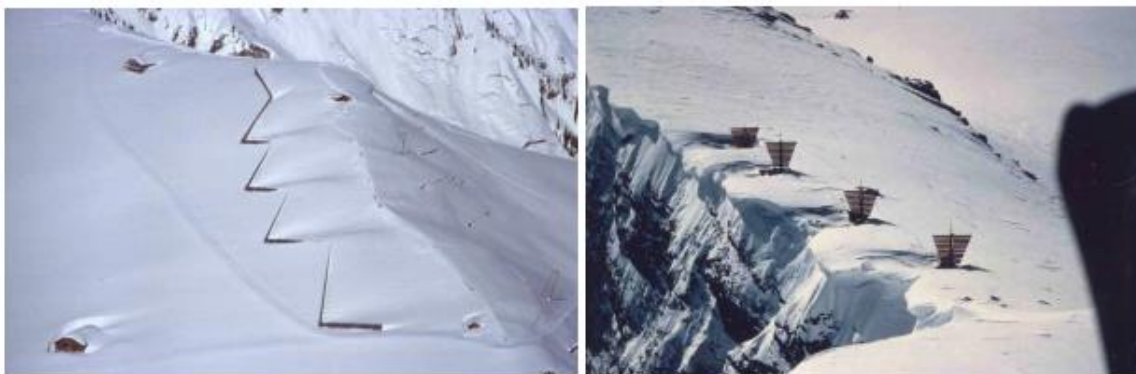
Figure 1-3: Snow fences to the left and wind baffles to the right (Hákonardóttir et al., 2008). Note the increased deposition around the snow fences and the increased erosion around the wind baffles.

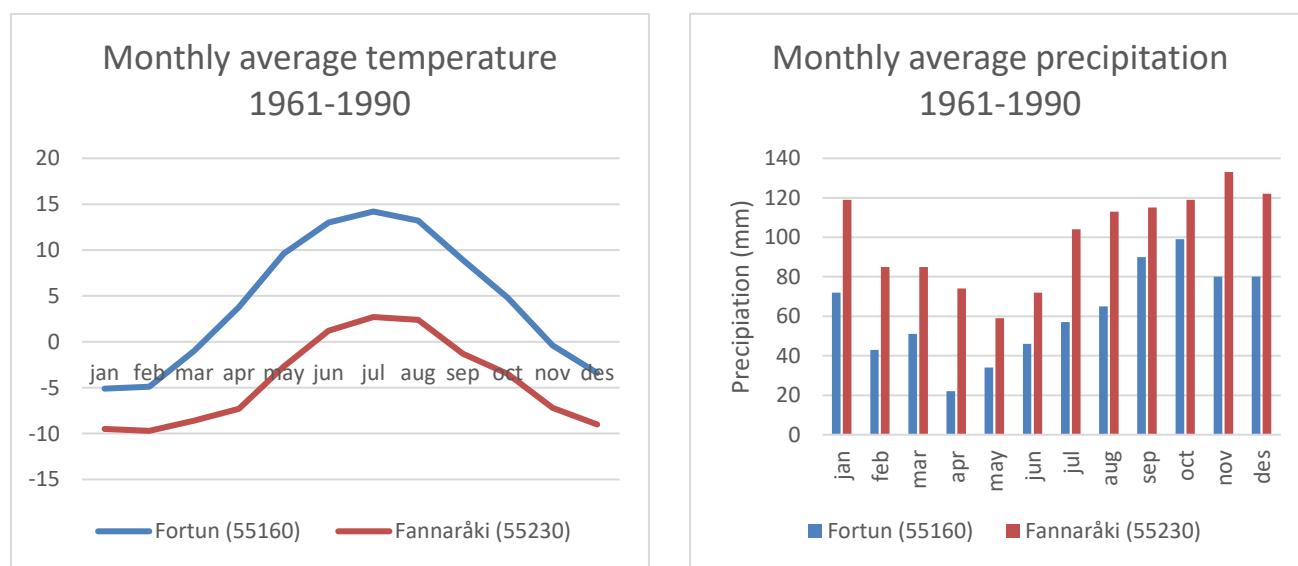
Figure 2-4: Monthly average temperature and precipitation from 1961-1990 from meteorological stations in Fortun (Station nr. 55160) and Fannaråki (Station nr. 55230). (Meteorologisk institutt)

Annual precipitation varies from around 700-800mm along Lustrafjorden to around 2200-2300mm in parts of Breheimen. Interpolated precipitation data from SeNorge indicates that annual precipitation for Kvannberget is in the range of 2000-3000mm. Hurrungane to the south has an annual precipitation of around 1300-1400mm (**Figure 2-4**).

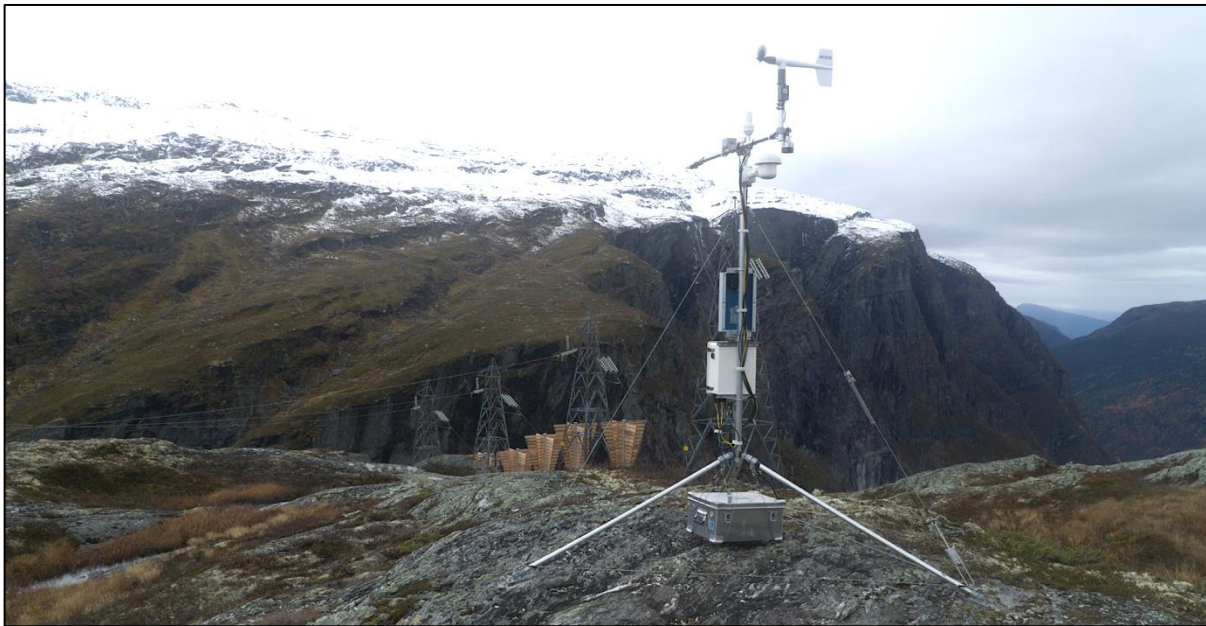
Figure 2-6: The automatic weather station was placed to the Northeast of the wind baffles on an elevated surface. Wind measurements were made at a 3.1m height by the anemometer seen on top of the boom. The boom is mounted in a North-South orientation.

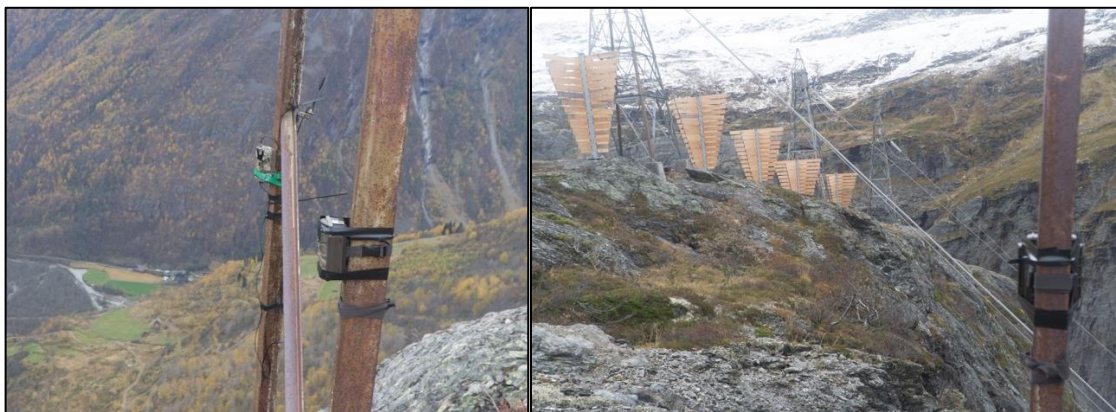
Figure 2-7: Two cameras were placed on a ridge to the North of the wind baffles and provide a view over the area previously subjected to cornice growth, as well as the control area. The cameras were pointing southwards.

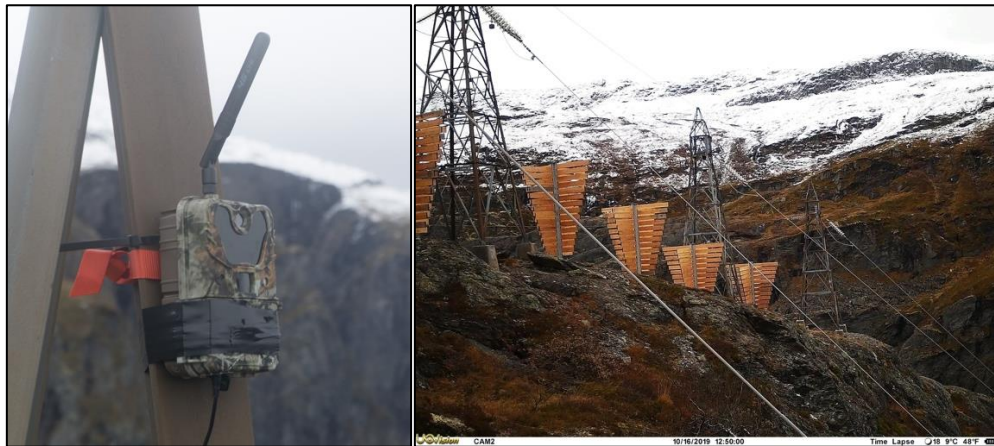
Figure 2-8: Left: The Uovision UM785-4G with external antennae to increase reception. Right: Example of an image downloaded through the cloud service. This feature was used several times to check if the cameras were operating normally.

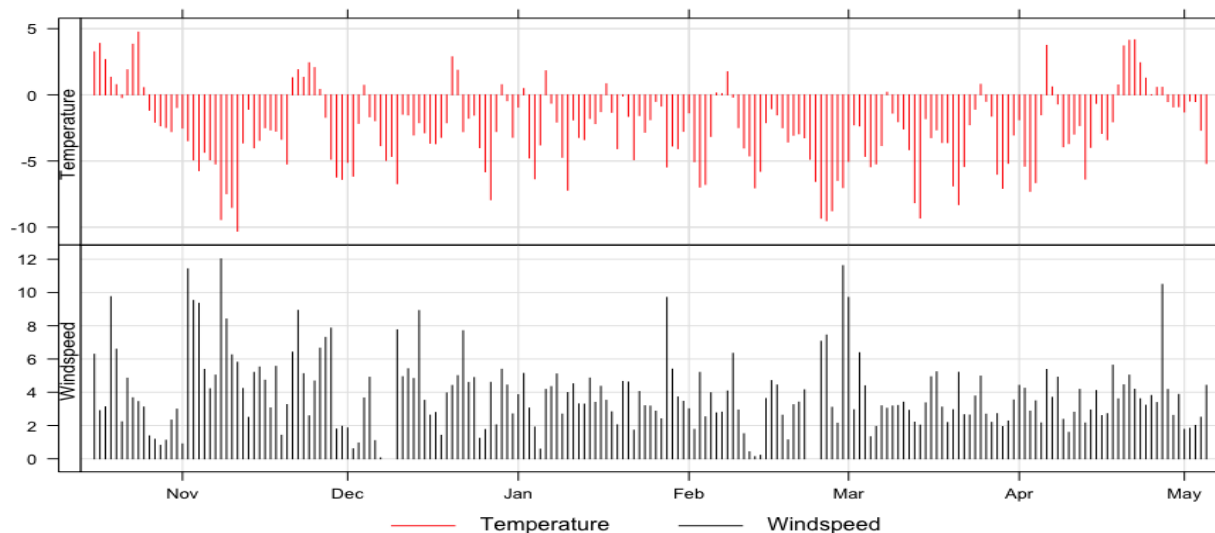
Figure 3-1: Daily average temperature (red) and wind speed (black) data from the AWS. The temperature started dropping at the end of November and mainly stayed below freezing to the start of April. The hourly average temperature was -2.6°C and hourly average wind speeds was 3.95 m/s.

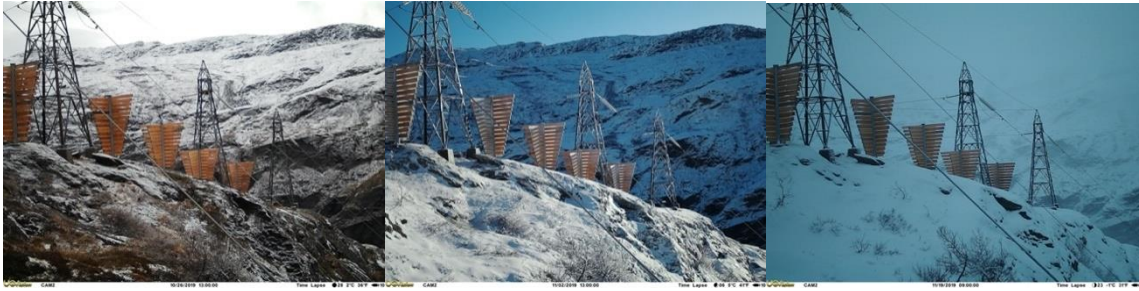
Figure 3-4: No cornice accretion occurred during October and November. Images from Cam 2. From the left: 26.10.2019, 02.11.2019, 19.11.2019.

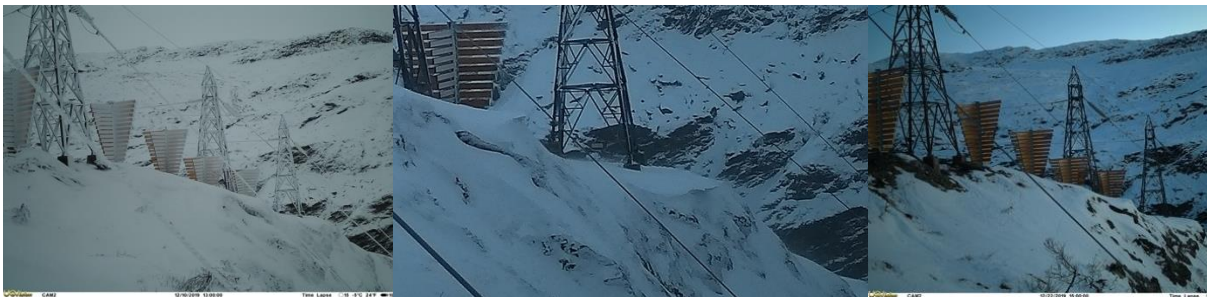
Figure 3-5: The first accretion event could be seen 14.12.19 (pictured in the middle). A cornice developed in the reference area as well as on the outcrop between baffle 3 and 4. Images from Cam 2. From the left: 10.12.2019, 14.12.2019, 22.12.2019

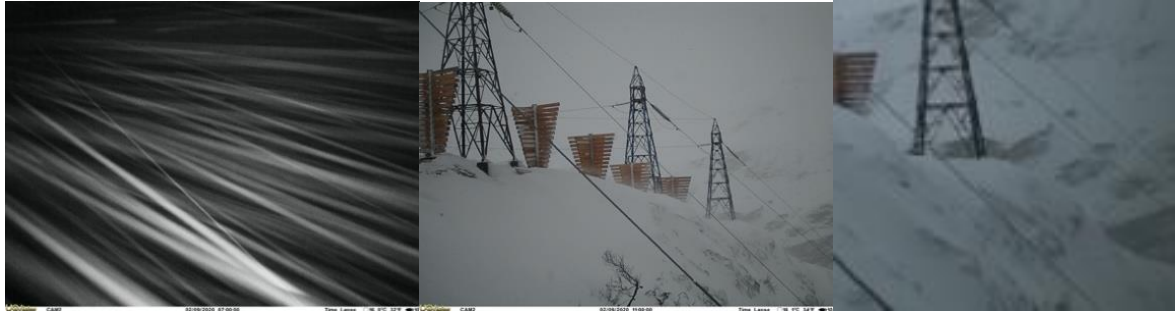
Figure 3-6: Images from cam 2 from morning to afternoon on 09.02. Precipitation with winds from the North-East was observed during the night. Drifting could be seen at 11:00 and the apparent cornice structure was visible at 15:00 (image on the right).

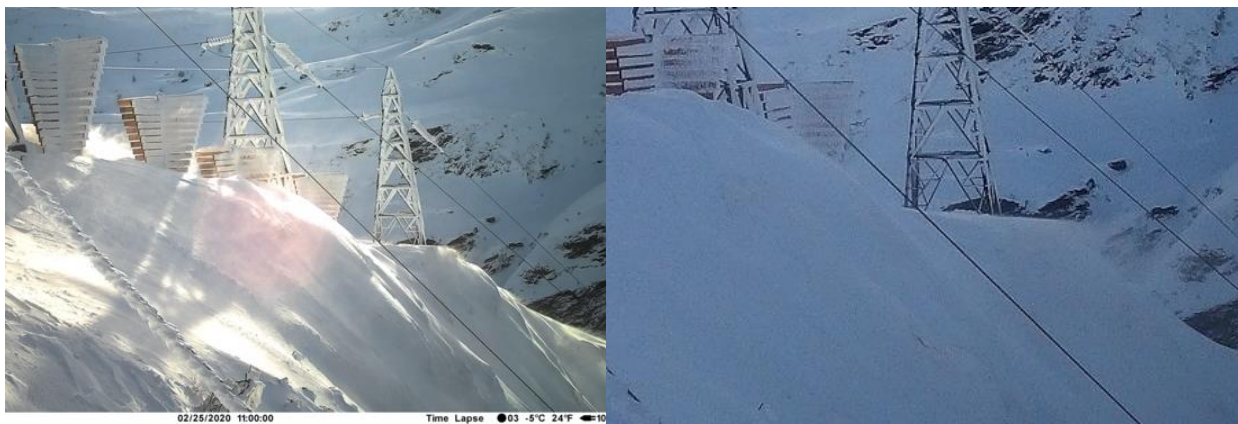
Figure 3-7: A new cornice structure was visible in the reference area on images from 25.02. Images from cam 2 showing drift events 25.02.20 (to the left) and 26.02.20 (to the right).

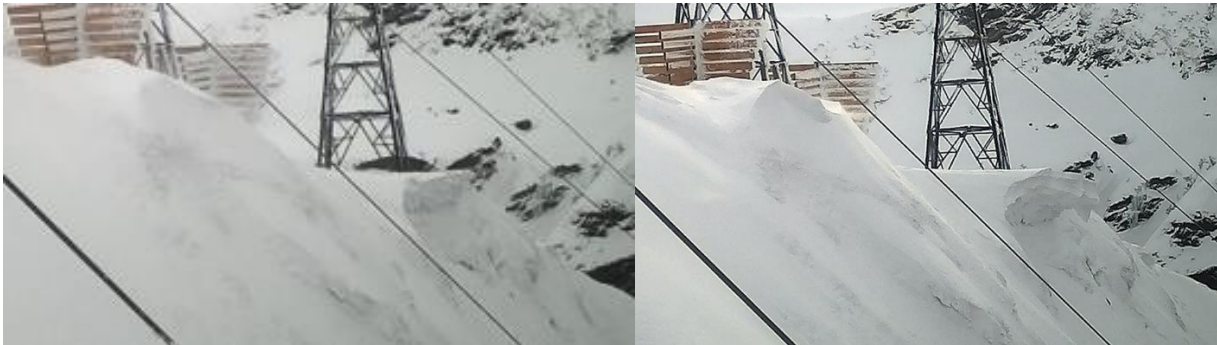
Figure 3-8: Images from Cam 2 taken 22 hours apart showing an increase in horizontal extent of the cornice in the reference area as well as the development of a cornice structure between baffle 3 and 4. On the left: 29.02 13:00. On the right: 01.03 11:00.

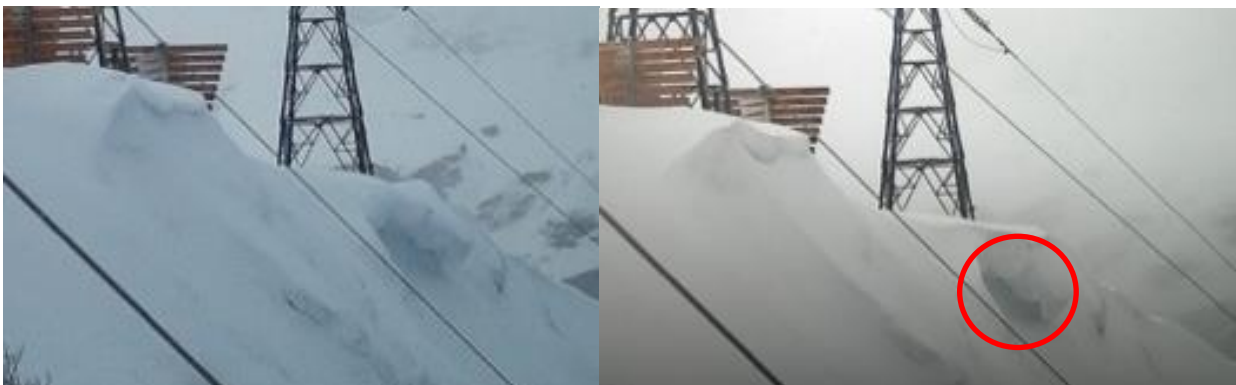
Figure 3-9: By 15.03 the cornice face had almost deformed enough to create a roll cavity (red circle). Images from Cam2 09.03 (left) and 15.03 (right).

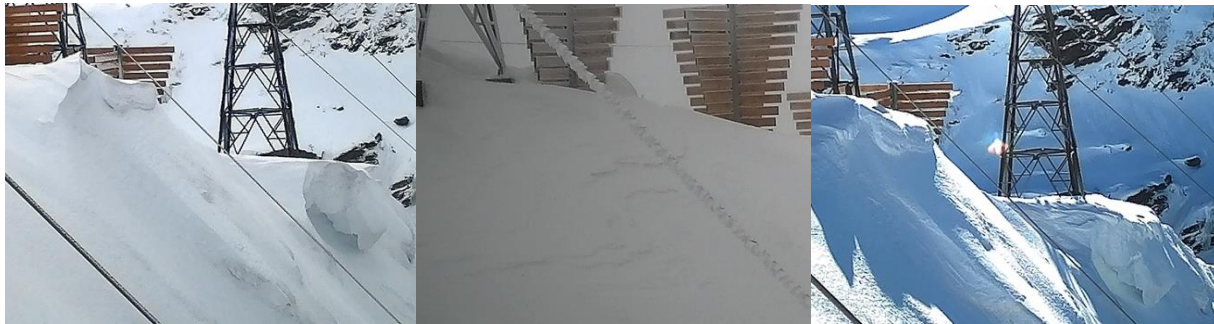
Figure 3-10: 16.03 (left): Sheet growth on the cornice in the reference area, 18.02 (middle): Sastrugi depict a winds blowing against the ridgeline, and 21.03 (right): The cornice structure became rounded with temperatures above freezing and insolation. Images from Cam 2.

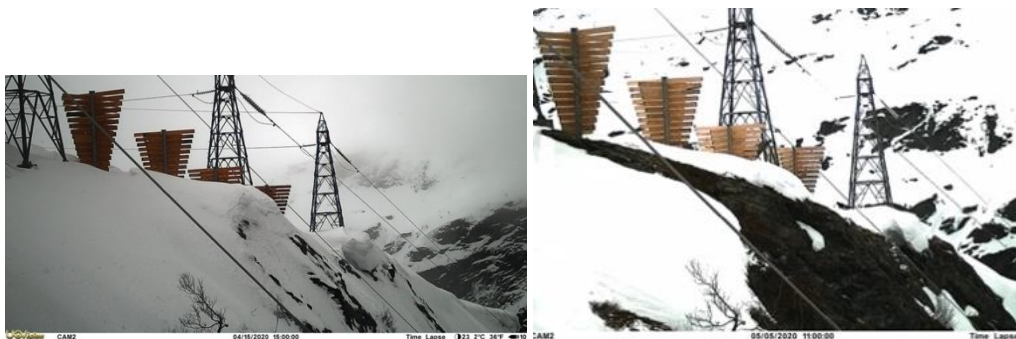
Figure 3-11: Increasing temperatures and insolation rapidly lead to a decrease in the snow cover. Images from Cam 2. 15.04 (left) and 05.05 (right).

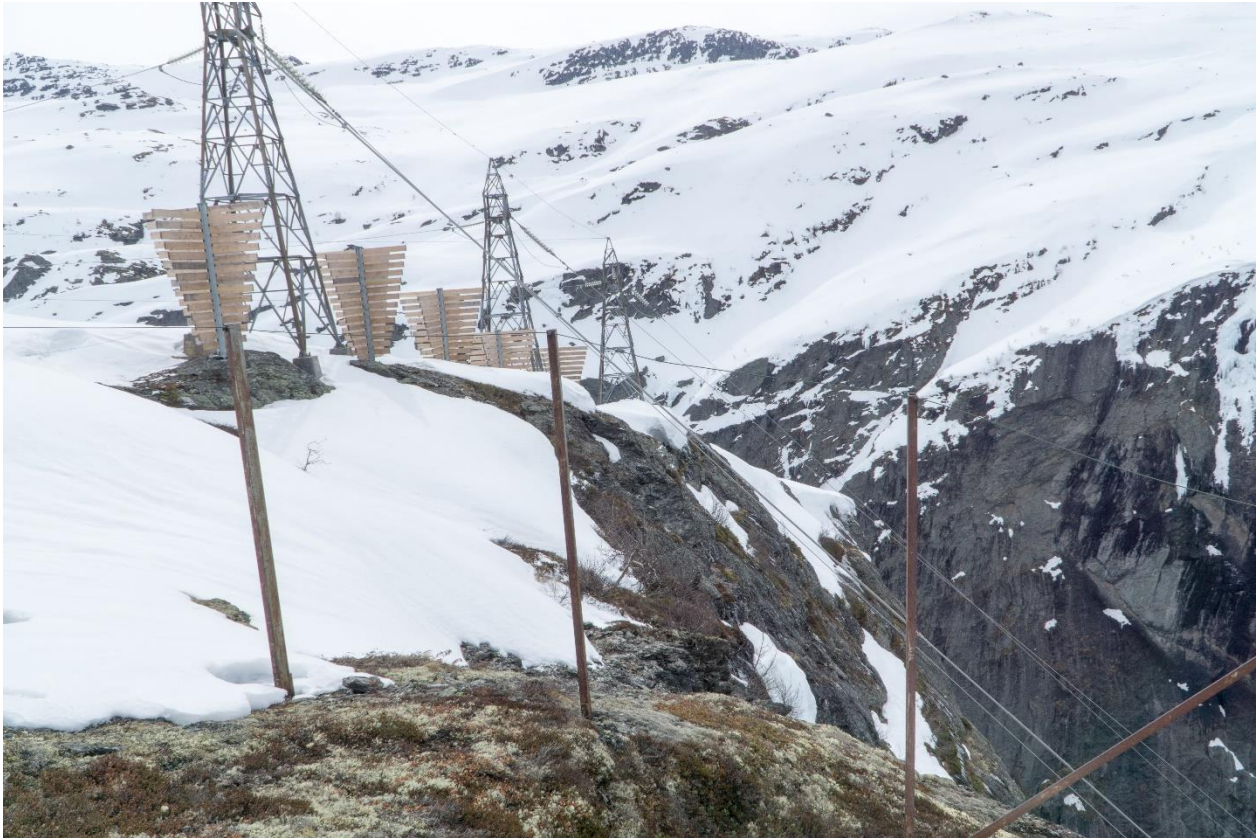
Figure 3-12: The snow cover had been notably reduced by 05.05.20. Note the bare ground around the closest baffle.

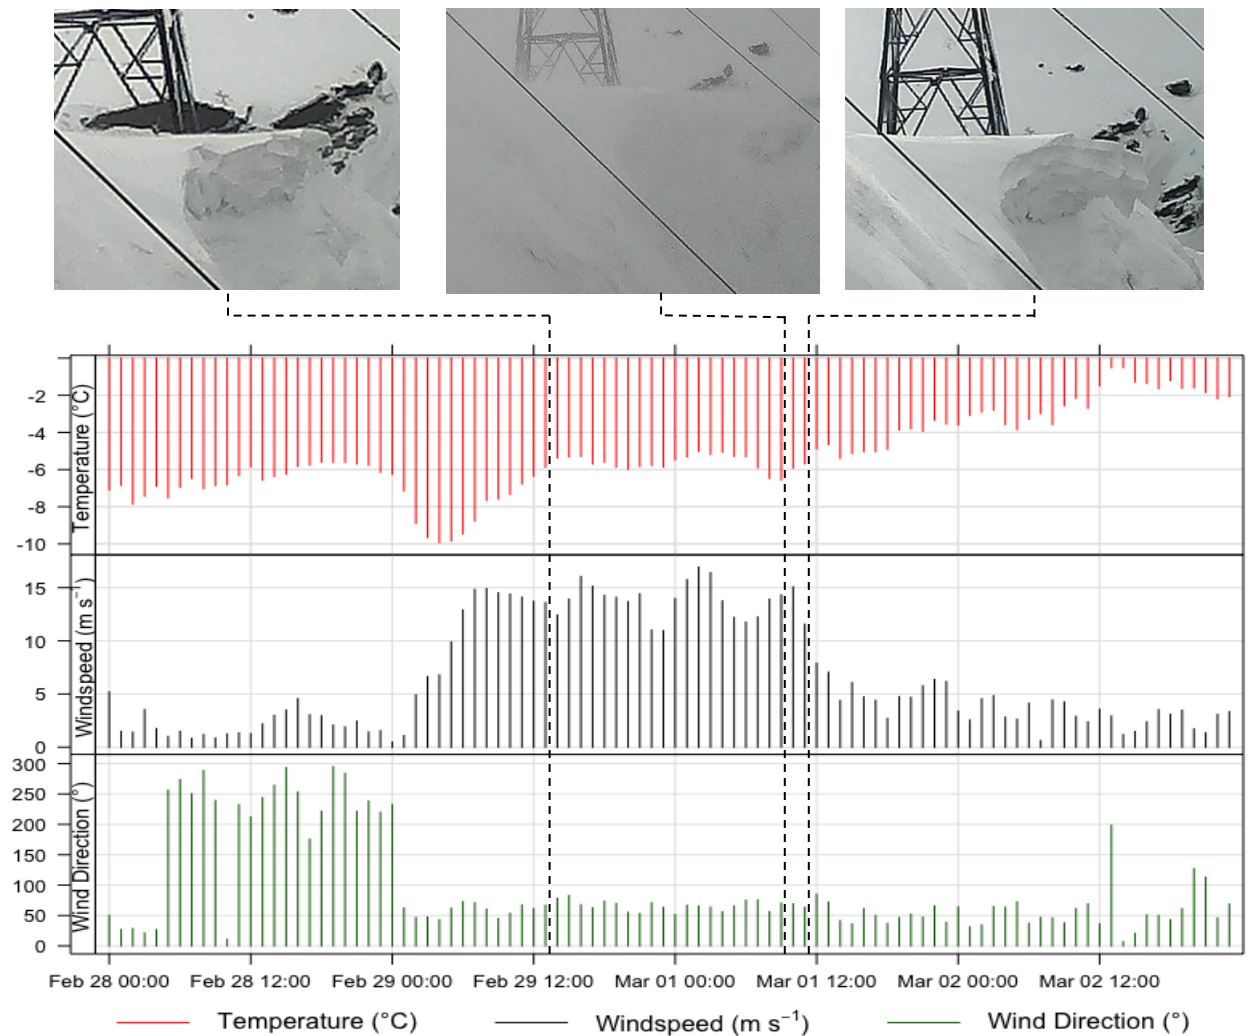
Figure 3-14: Hourly average temperature, wind speed and wind direction for the drift and accretion events observed between 29.02-01.03. Images from Cam 2 of the reference cornice are timestamped (dotted black line). A horizontal extension of the cornice structure was observed from 13:00 29.02 (image on the left) to 11:00 01.03 (image on the right). The image in the middle shows drifting at 09:00 01.03.

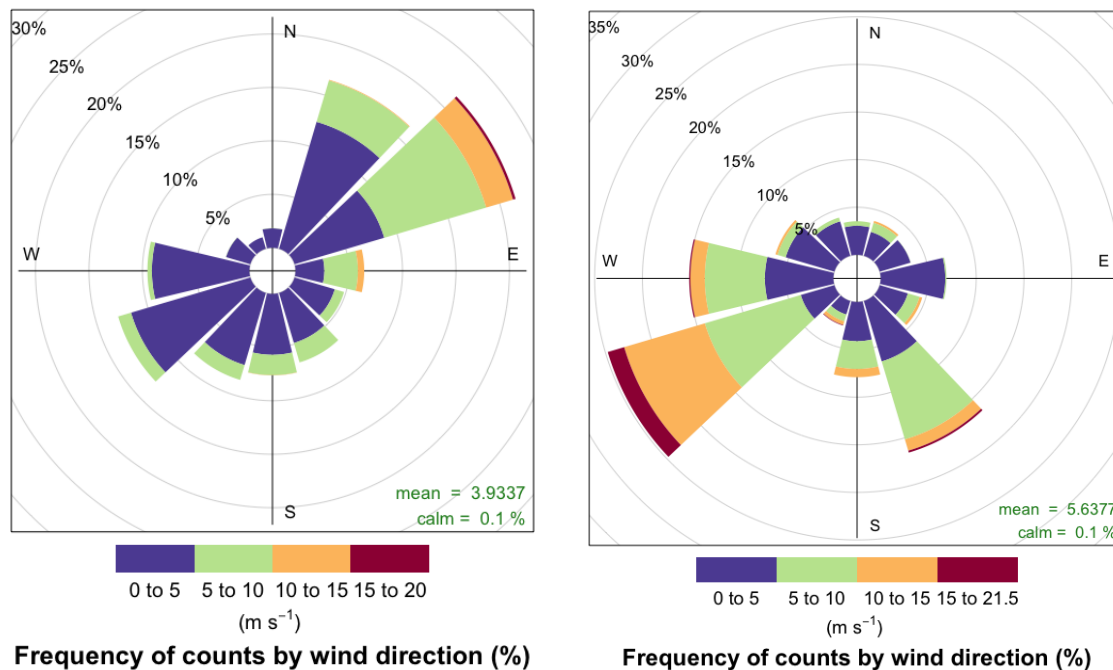
Figure 3-17: Wind rose showing the frequency distribution for wind direction and speed for hourly averages for the AWS (left) and Sognefjellet (right). Wind speeds above 10 m/s at Kvannberget mainly occurred with the predominant wind direction from East North-East. West South-Westerly winds were the most common at Sognefjellet and the direction associated with the highest wind speeds.

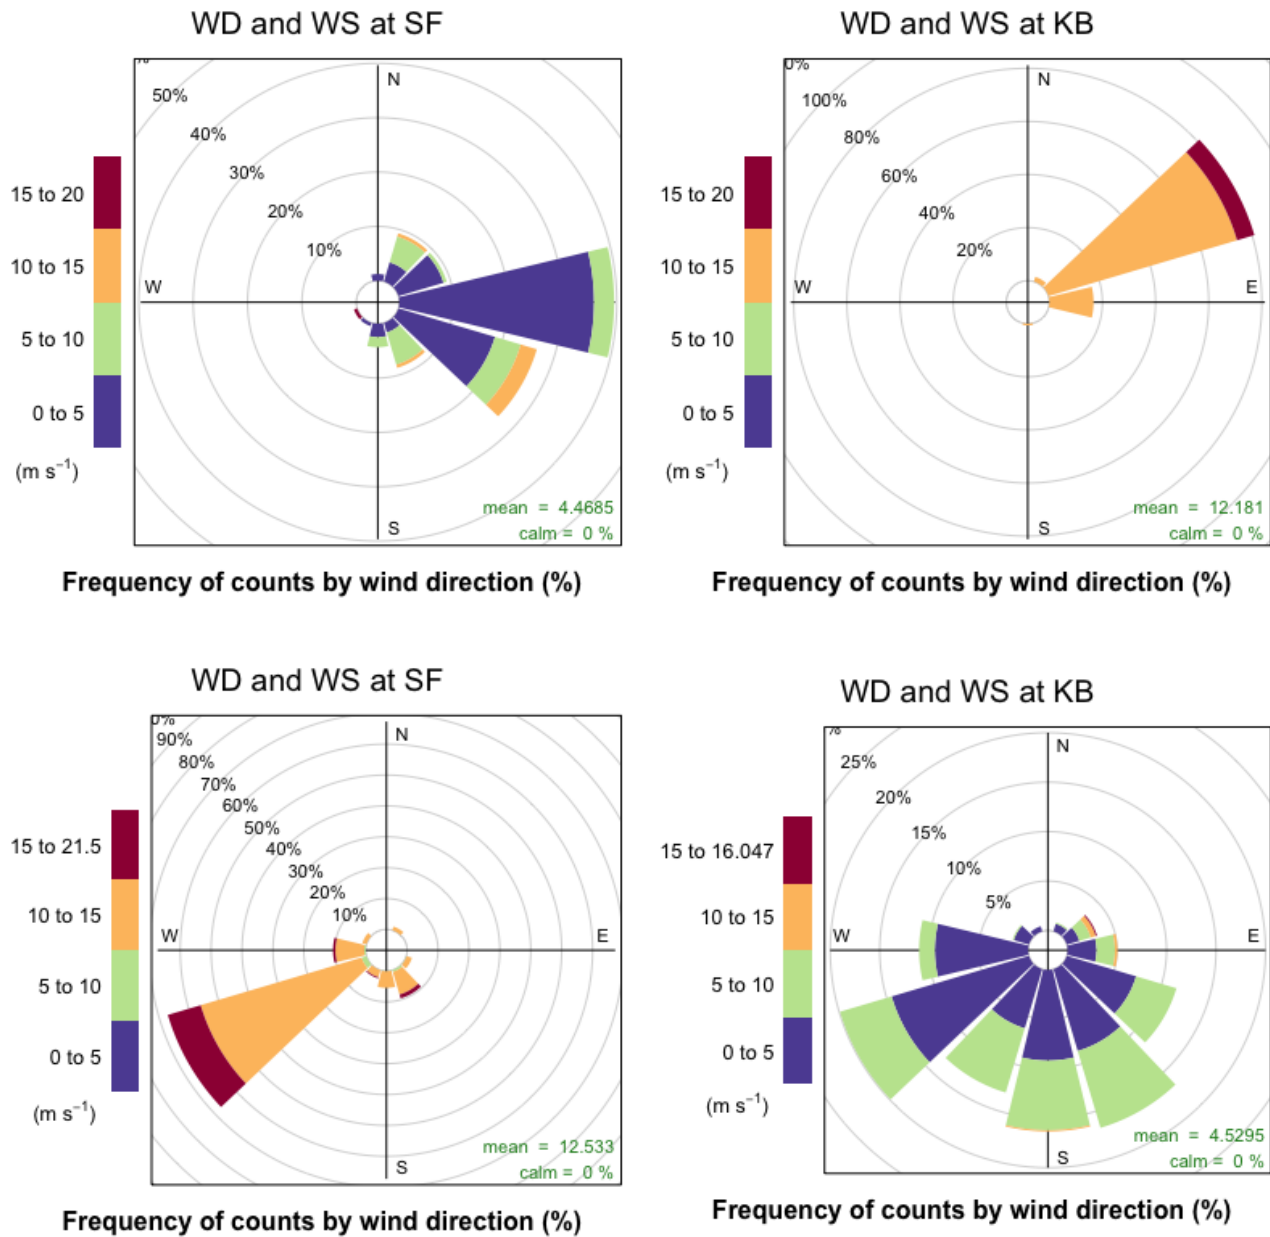
Figure 3-19: Wind roses for conditions at Kvannberget (KB) and Sognefjellet (SF) during periods with wind speeds above 10 m/s. Easterly winds at Sognefjellet results in North Easterly winds at Kvannberget. High wind speeds at Sognefjellet does not result in high wind speeds at Kvannberget. WD: Wind direction. WS: Wind speed.

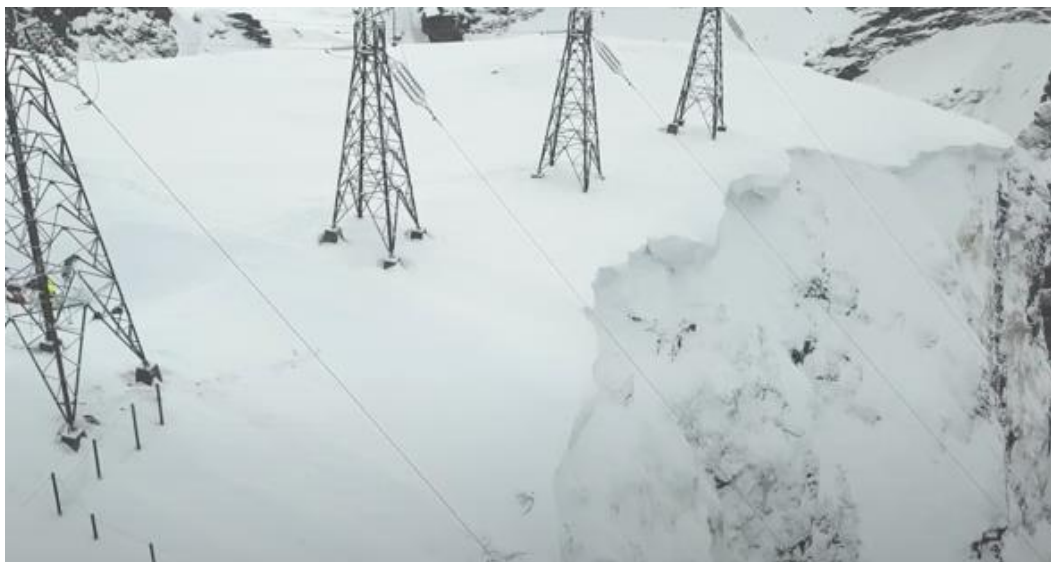
Figure 3-20: Aerial image before explosive work was conducted 21.02.2018. A long continuous cornice had developed along the ridge and the powerline on mast 2 had come in contact with the snow.

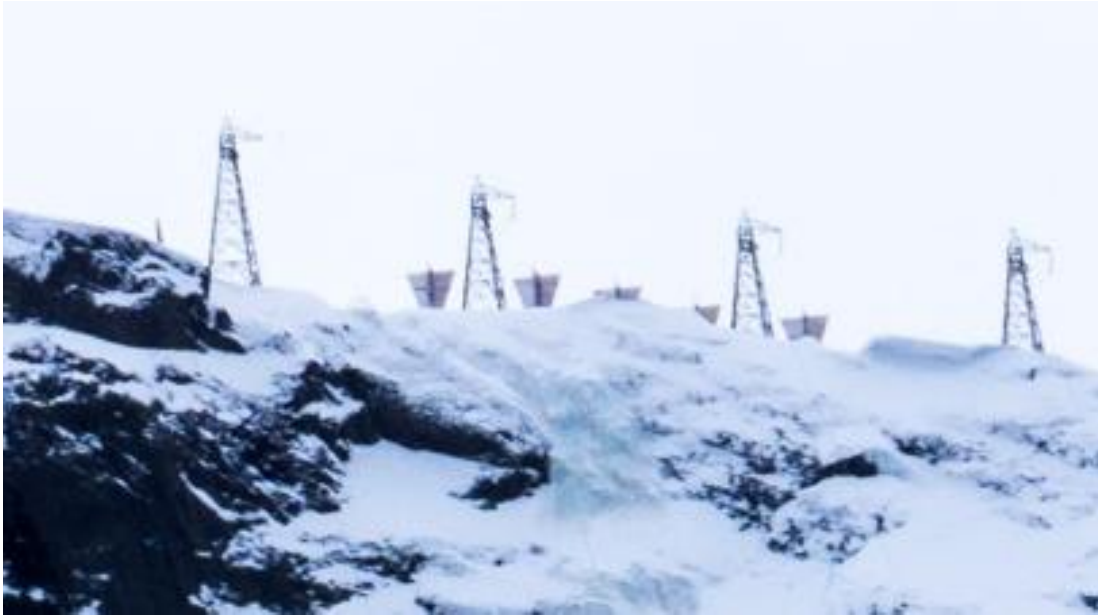
Figure 3-21: The ridgeline at Kvannberget seen from below. No continuous cornice had developed by 06.03.20. The cornice structure seen between the two masts on the right was used as the reference cornice. Image taken during field work 06.03.20

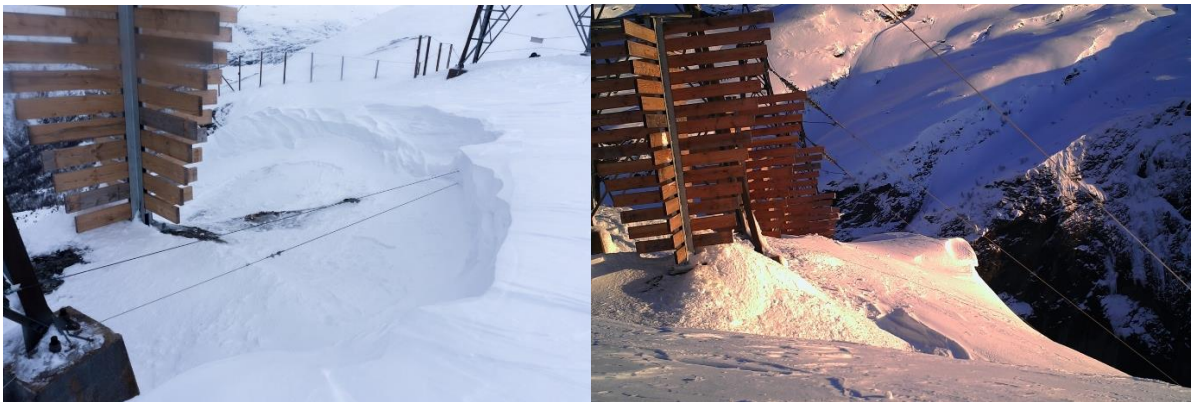
Figure 3-22: Images showing the development of scours around the wind baffles. On the left: The scour was well developed around Baffle nr 1 during fieldwork 06.03. On the right: Image from Cam 4 showing the scour around baffle 1 on the ridge side. Note the increased snow height on the lee side of baffles 3 and 4 in the background.

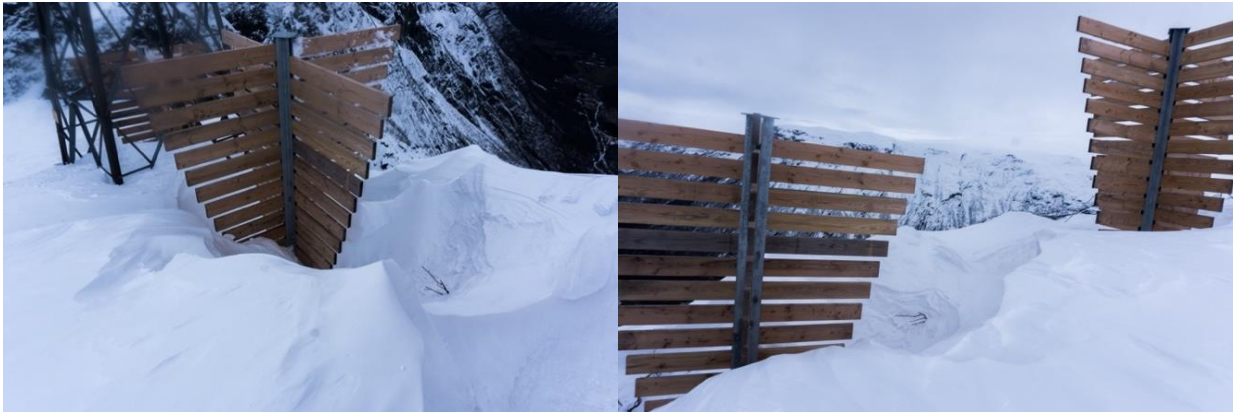
Figure 3-23: Snow had deposited on the lee side of baffles 3 and 4. On the left: The scour around baffle 4 was notably smaller than the other scours. Snow had deposited in contact with the bottom of the baffle. An elevated snow surface can be seen between the scour around baffle 4 and 3 (to the right of the frame). On the right: Snow had deposited on the lee side of baffle 3 (right) and 4 (left). Snow height on the windward side of baffle 4 was notably higher than for baffle 3.

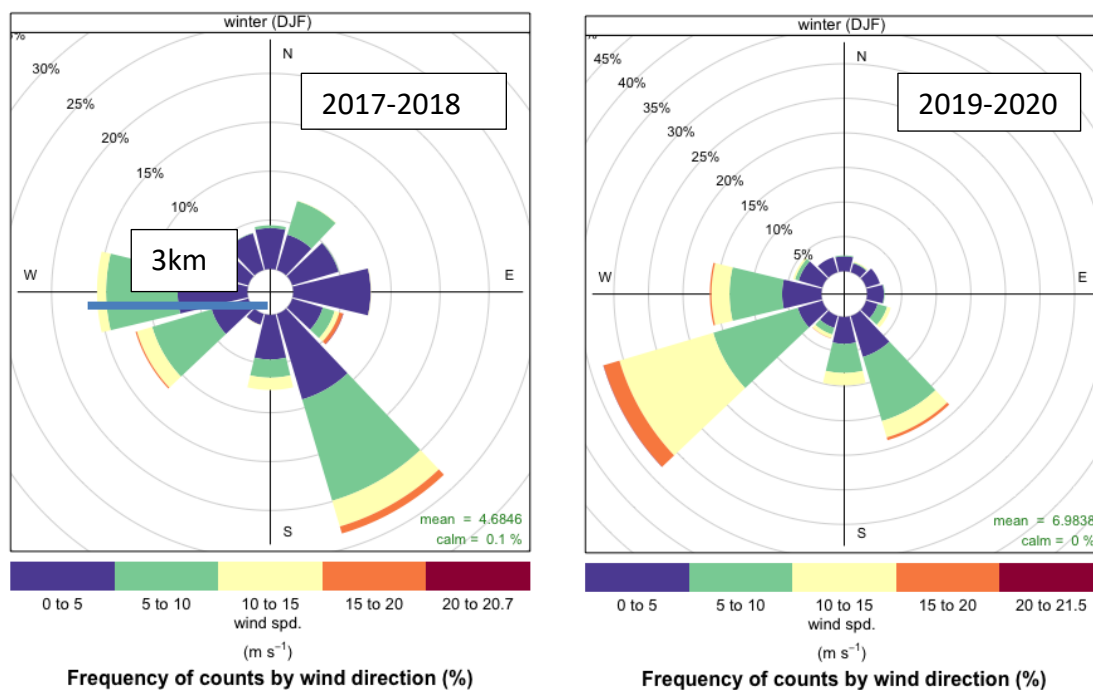
Figure 4-1: Frequency distribution of wind speed and wind direction at Sognefjellet for the winter months of 2017-2018 (on the left) and 2019-2020 (on the right). The predominant wind direction for 2017-2018 was from South South-East. During the same months in 2019-2020 the predominant wind direction was from West South-West.

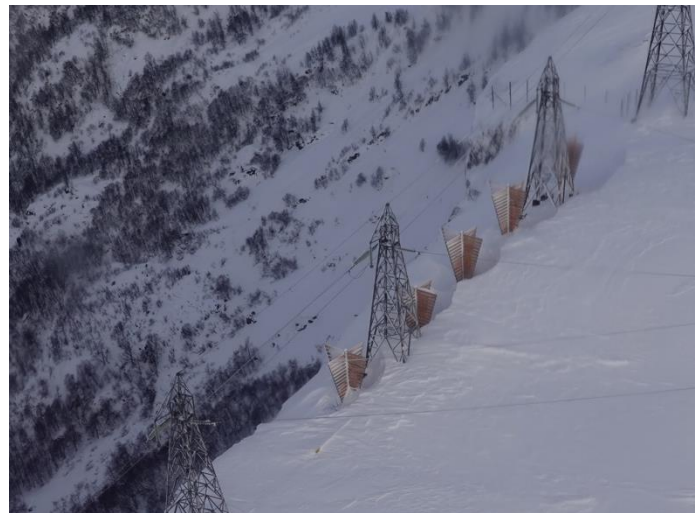
Figure 4-2: Aerial image of the field site taken 27.02.20. A distinct decline of the snowpack can be seen windward of the baffles.

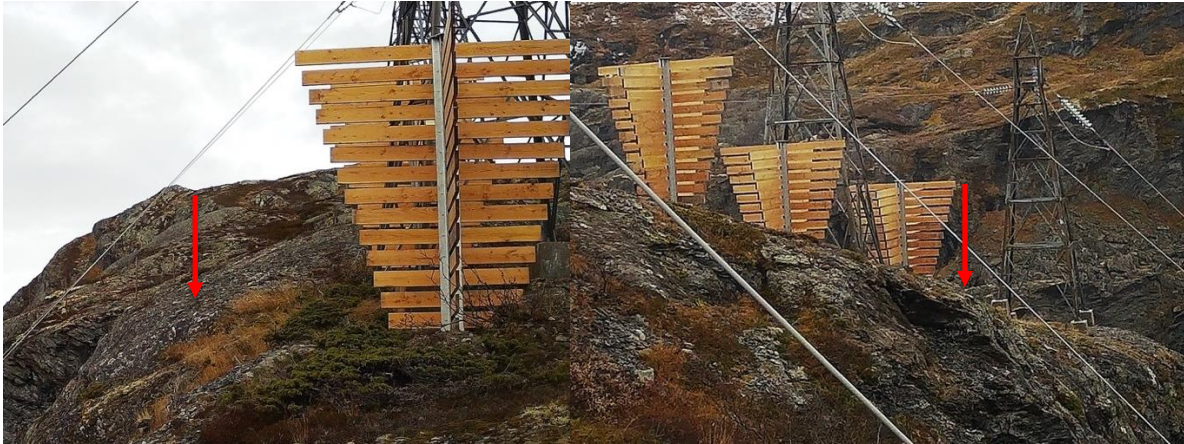
Figure 4-3: Images from Cam 1 and Cam 3 showing the position of the rocky outcrop (red arrow) ridge ward of baffle 3 and 4. A small cornice developed at this location during the monitoring period.

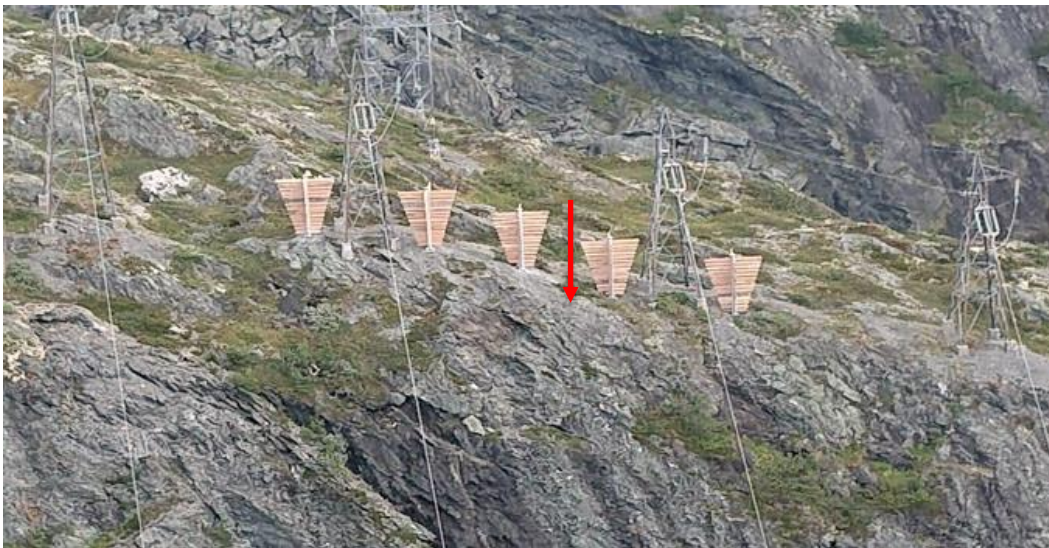
Figure 4-4: The field site seen from the West. The red arrow indicates the area where a small cornice developed during the observation period. This area is situated between two of the power masts and an increased horizontal extent would not constitute a problem for the power lines.
