Analysis of a Costly Fiberglass-Polyester Air Filter Fire

Abstract: In September 2020, a fire at a liquefied natural gas (LNG) plant in the Arctic areas of Norway received national attention. In an unengaged air intake, the heat exchanger designed to prevent ice damage during production mode, was supplied hot oil at 260 °C. In sunny weather, calm conditions, and 14 °C ambient temperature, overheating of the unengaged air intake filters (85% glass fiber and 15% polyester) was identified as a possible cause of ignition. Laboratory heating tests showed that the filter materials could, due to the rigid glass fibers carrying the polymers, glow like smoldering materials. Thus, self-heating as observed for cellulose-based materials was a possible ignition mechanism. Small-scale testing (10 cm × 10 cm and 8 cm stacked height) revealed that used filters with collected biomass, i.e., mainly pterygota, tended to self-heat at 20 °C lower temperatures than virgin filters. Used filter cassettes (60 cm by 60 cm and 50 cm bag depth) caused significant self-heating at 150 °C. At 160 °C, the self-heating took several hours before increased smoke production and sudden transition to flaming combustio

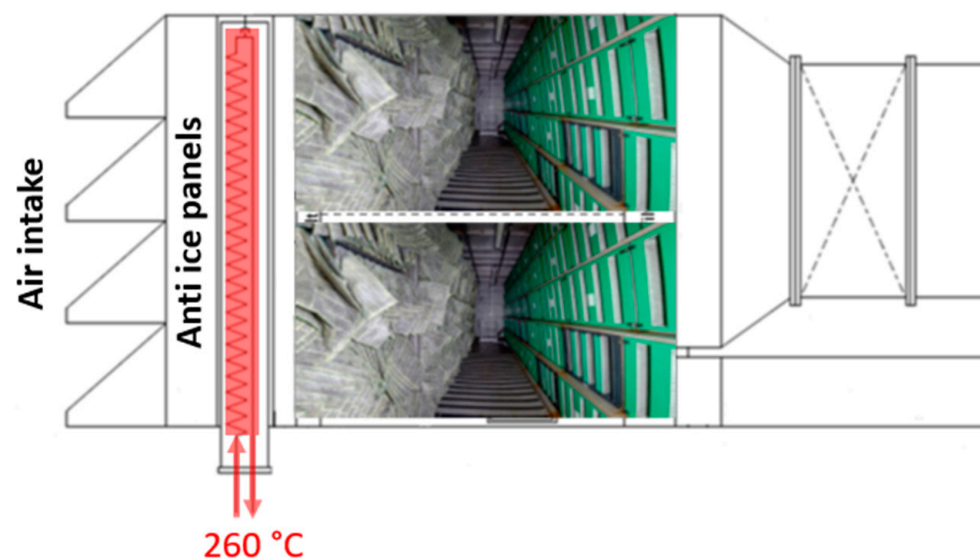
At normal speed, each GTG consumes about 100 m^3 air/s. The supply air passes through an upstream filter house with coarse and fine filters to prevent turbine damage by alien objects. Acceleration of the air through the air intake and pressure reduction through the coarse and fine filters result in air expansion and adiabatic cooling [4]. For given combinations of temperatures just around and below the freezing point, and high relative humidity, ice may form in the filters. This ice may block the filters as well as represent alien objects that may damage the turbines. Thus, the supply air must be preheated to prevent ice formation. At the LNG plant, hot oil (Renolin Thermoil 30, Fuchs, Mannheim, Germany) heated to $260 \text{ }^\circ\text{C}$ in the turbine exhaust heat recovery unit is used as an internal energy carrier [5]. This hot oil is also used for preheating the GTG supply air a few degrees when there is risk of supply air ice formation. The heat exchanger comprises horizontal 15 mm outer diameter metal pipes carrying the hot oil. A principal sketch of the filter house is shown in Figure 2.

Figure 2. A principal sketch of the unengaged air intake, with coarse filters (left) and fine filters (right), while the heat exchanger was supplied hot oil at $260 \text{ }^\circ\text{C}$.

At first, there were no clues as to what could have ignited an unengaged air intake, i.e., at a GTG not in operation on the day of the fire. It turned out, however, that the air intake heat exchanger had been supplied with hot oil at 260 °C several hours before the fire took place. It was therefore decided to test virgin and used filters and check whether self-heating at elevated temperatures could have been the cause of the fire.

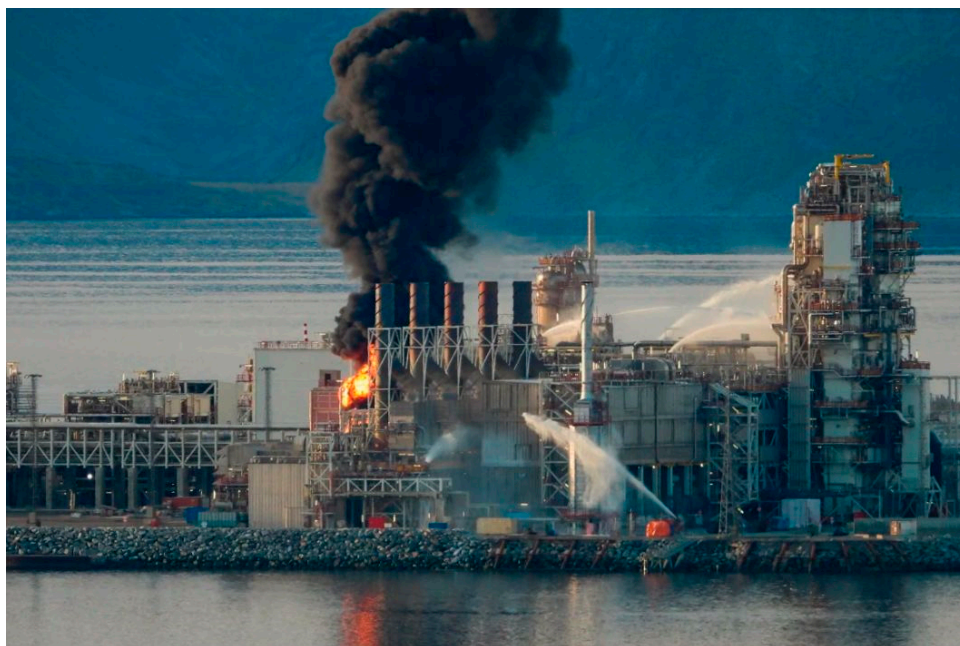
Due to a national grid anomaly, the plant tripped and had been out of operation for 10 days. During the start-up, 28 September 2020, four out of five GTGs were engaged while GTG 4 was left unengaged. To prevent overheating of the hot oil prior to engaging boilers, etc., some hot oil at $260 \text{ }^\circ\text{C}$ was supplied to the unengaged GTG4 air intake heat exchanger to dump excessive heat. In sunny weather, calm conditions, and $14 \text{ }^\circ\text{C}$ ambient temperature, overheating of the air intake filters (85% glass fiber and 15% polyester) was identified as the possible cause of a fire observed in GTG number 4, as seen in Figure 3.

Figure 3. The air intake hot oil fire. (Photo: Bjarne Halvorsen, reproduced with permission).

The production area was evacuated, blowdown was initiated, and fire water monitors were engaged, as seen in Figure 3. Later, tugboats and an offshore supply vessel with firefighting (FiFi) capacity were engaged to put out the fire. It should be noted that the fire was contained to the involved air intake and did not spread to production-related hydrocarbon-containing pipes or process equipment. The fire damage, as such, was quite limited [4]. Large amounts of seawater from the fire extinguishing did, however, damage other auxiliary systems such as electrical equipment and cables [5]. Thus, the plant was shut down for a lengthy repair and maintenance period, and out of service for more than 1.5-year including delays due to the COVID-19 pandemic prior to the startup on 17 May 2022.

CFD modelling using the Fire Dynamics Simulator (FDS) [9,10] confirmed that temperatures sufficient for initiating used filter bag self-heating was likely on a calm and sunny day with ambient temperature 14 °C. This strengthens the assumption that an unengaged air intake filter heated by the engaged heat exchanger resulted in used filter self-heating, and transition to flaming combustion. When flaming combustion took place, the heat exchanger pipes could not survive, i.e., broke and released 260 °C hot oil, changing this to an oil fire, evidenced by the thick black smoke plume as seen in, e.g., Figure 3.

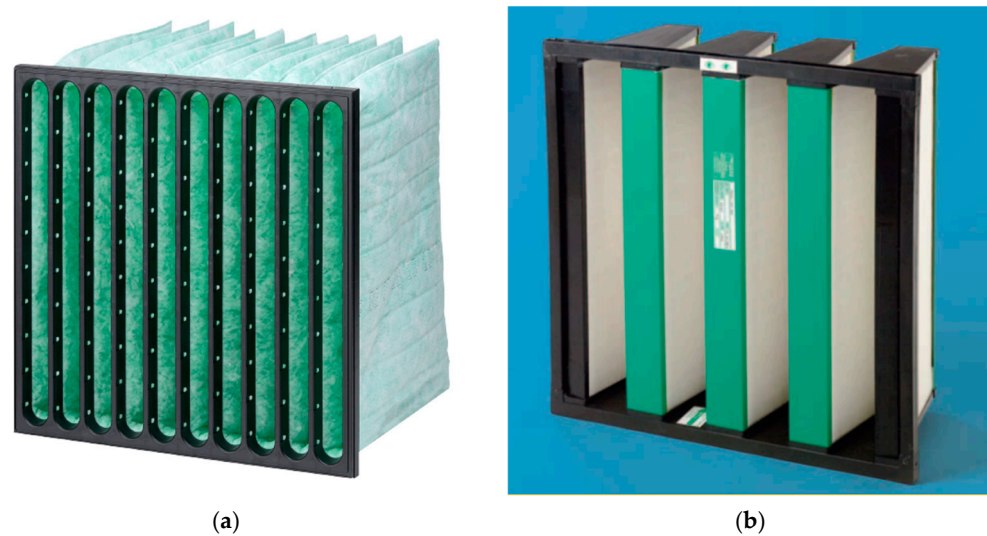
The coarse and fine filters were made of polyester (15%) and glass fiber (85%). The filters were of the types Hi-FLO XLT and Cam-GT-98klasse F9, respectively, from Camfil Inc [7]; see Figure 4. Samples were collected from virgin filters and from used filters in one of the undamaged air intake filter houses, for both small-scale and filter cassette-scale analyses.

Figure 4. Air intake (a) coarse bag filter (Hi-FLO XLT); (b) fine filter (Cam-GT-98 klasse F9), [7].

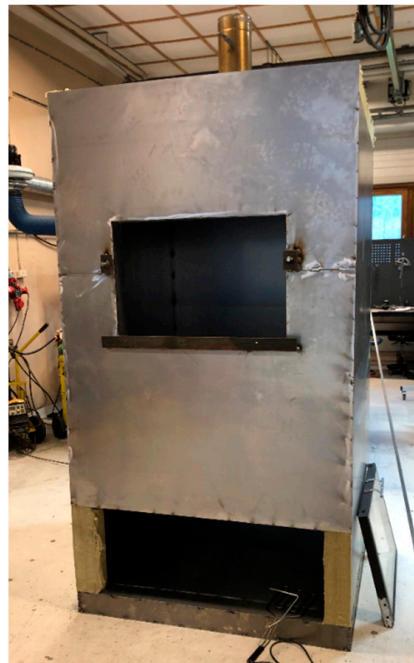
Based on the results of the small-scale testing, it was decided to also test complete filter cassettes (60 cm by 60 cm and 50 cm bag depth) at elevated temperatures, which required a much larger test volume. A 2 m³ test chamber was therefore built for this purpose, as seen in Figure 5.

Figure 5. The 2 m³ test chamber for testing filter cassettes.

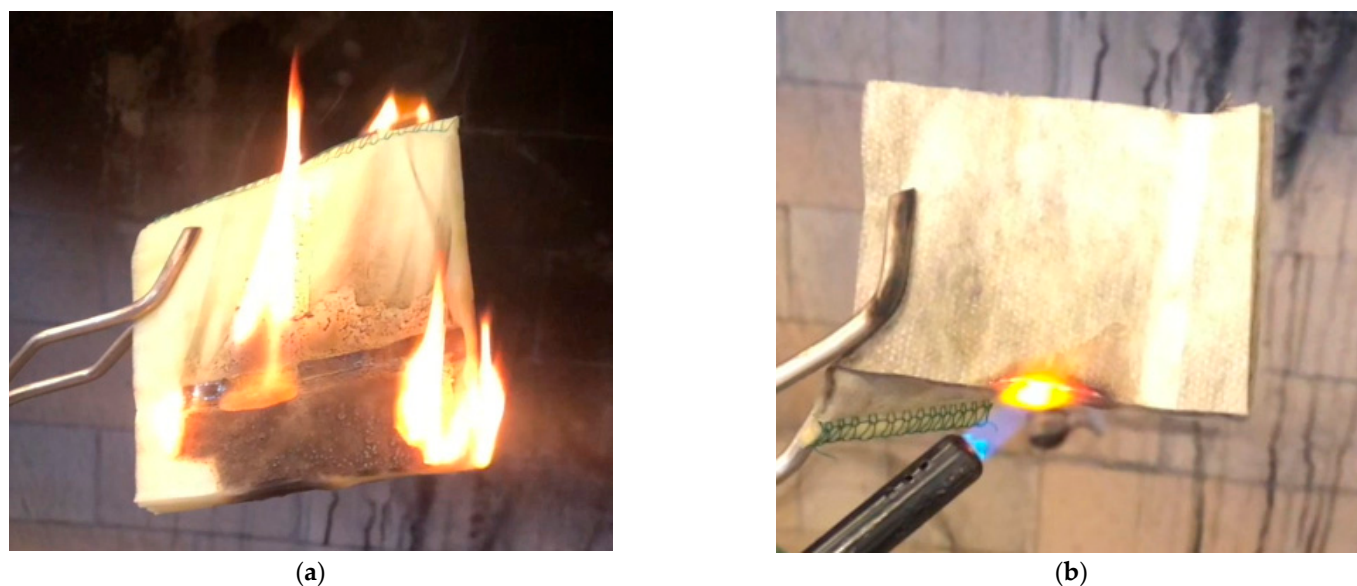
Figure 6. Initial Ignition Tests: (a) Flaming combustion of filter test specimen; (b) ignition test demonstrating glowing glass fibers.

It was quite apparent that the filter material could sustain flaming combustion, as seen in Figure 6a. When exposed to prolonged heating, as shown in Figure 6b, glowing was observed due to the hot, but still rigid, glass fiber structure. This glowing could not have been caused by the polyester, which would melt and shrink away from a heat source. Materials with this melt and shrink behavior are known to not be involved in smoldering combustion [8]. The glowing of rigid structures is one of the prerequisites associated with the self-heating and smoldering of materials such as hay or organic oil-filled rags [8]. In, e.g., cellulosic materials, the char that forms when the material is pyrolyzed represents this solid structure. Regarding the filters, there was a possibility that the glass fiber played the same role as a stiff material, thus preventing the polyester from shrinking away from the heated zone. It was therefore decided to perform small-scale self-heating tests to reveal any potential thermal runaway reactions that could eventually lead to a transition to flaming combustion.

Initial ignition tests revealed that the filters showed a solid structure that glowed upon heating due to the embedded glass fiber matrices. This indicated that smoldering-like self-heating could be possible. Small scale (10 cm by 10 cm by 8 cm stack height) tests were conducted in a muffle furnace, and full-scale filter cassette tests were conducted in a heated 2 m² cabinet with a window for observations. Temperature recordings revealed that in both small-scale tests and filter-cassette scale tests, used filters self-heated and resulted in flaming combustion at significantly lower temperature than virgin filters. The used filters had accumulated biomass. It is likely that accumulated biomass, dominated by pterygota, added combustible materials to the used filters but also likely added active surfaces for oxidation and possible self-heating to take place at a lower temperature.

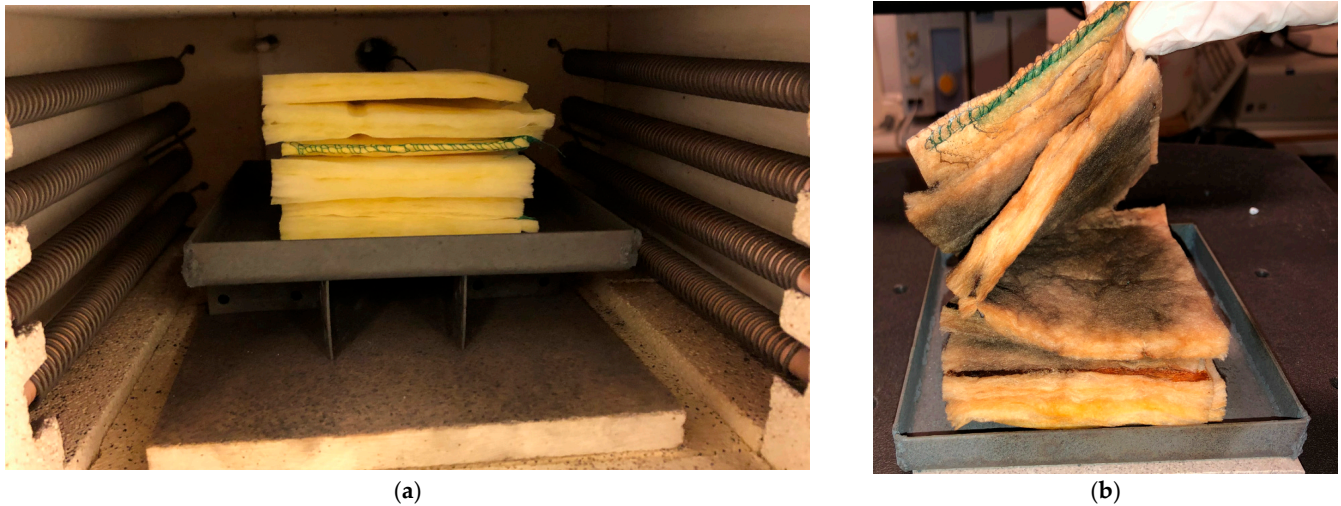
The test specimens of new and used coarse (bag) filters (10 cm by 10 cm stacked to 8 cm height) were heated in the muffle furnace, as shown in Figure 7 (virgin filters). One thermocouple (type K, 0.5 mm stainless steel mantel) was placed in the center of the test specimen filter stack, and one thermocouple was placed at the same elevation 10 mm from the edge of the stack.

The reason for placing the thermocouple 10 mm from the edge was to determine whether the self-heating was initiated at the surface of the test specimen stack due to the adjacent muffle furnace heating coils or at the center of the stack. It should also be mentioned that a fine-mesh steel screen was placed between the heating coils at each side of the muffle furnace to reduce the direct heat radiation from the heating coils to the test specimen during temperature ramp-up to the respective holding temperatures.

Figure 7. Self-heating tests in a muffle furnace: (a) The virgin test specimens (10 cm × 10 cm stacked to 8 cm height) and ready for testing at a given holding temperature. (b) After muffle furnace self-heating test, with visible indent marks by the thermocouples embedded during heat treatment.

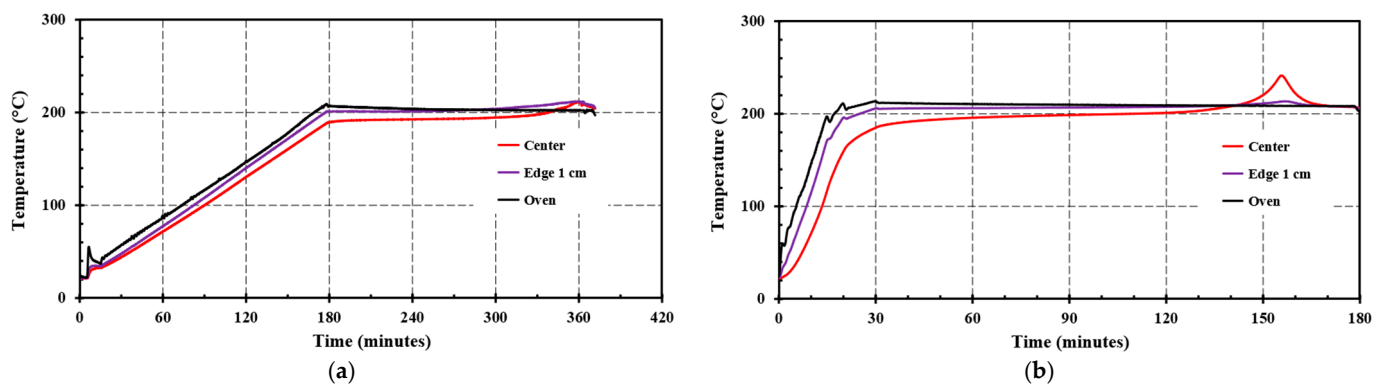
In the muffle furnace, new filters showed only a minor tendency to self-heat for set-point temperatures at, e.g., 200 °C to 205 °C, as shown in Figure 8a,b, with heating rates of 1 K/minute and 10 K/minute, respectively. It should be noted that these temperatures are well below the polyester melting point, which is typically in the range of 250 °C to 265 °C. The initiation of the self-heating process was slow, i.e., hours, at these set-point temperatures, and self-heating of the center of the test specimen stack was on the order of 5 K to 20 K, with no evidence of a runaway reaction. However, used filters at a similar

Figure 8. Temperatures recorded in virgin filters: (a) 1 K/minute heating rate and setpoint 200 °C; (b) 10 K/minute heating rate and setpoint 205 °C.

The temperature versus time development for the center thermocouple in Figure 8a,b, i.e., the new filters, was as expected by thermal conduction/thermal diffusion. For the used filters, Figure 9a,b, there was, however, a tendency for the center temperature, and partly also the temperature recorded 1 cm from the edge of the test specimen, to lag the oven temperature while below 100 °C. Plotting the time derivative of the temperature as a function of the recorded temperature, i.e., dT_i/dt versus T_i , for the temperatures presented in Figure 9a, reveals a minimum at about 56 °C, as can be seen in Figure 10.

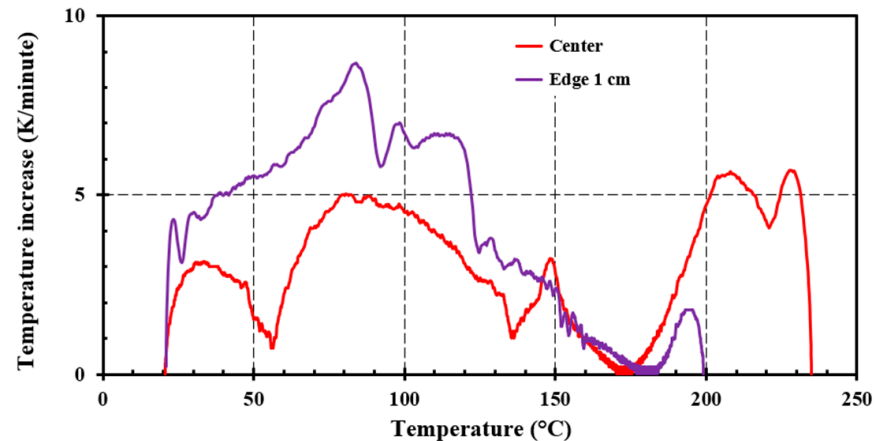
Figure 10. The time derivative of the temperature as a function of the temperature for used filters, i.e., data from Figure 9b.

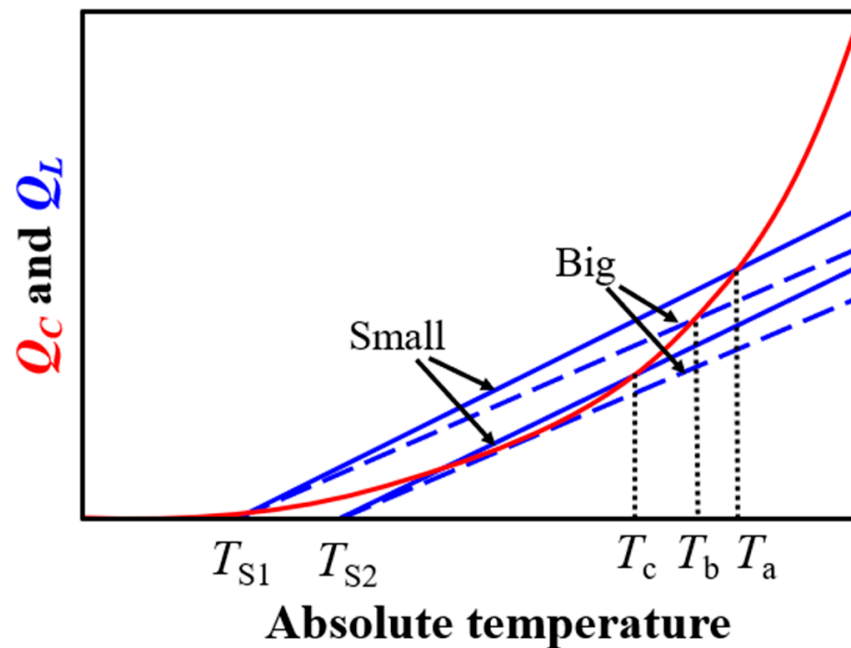
If the heat production overcomes the heat losses, then a runaway reaction starts; otherwise, the heat loss controls the test specimen temperature. This is schematically presented in Figure 11 for a small and a large sample placed at holding temperatures T_{S1} and T_{S2} . At set-point temperature T_{S1} , changing the sample size from small to large reduces the runaway temperature from T_a to T_b , or, for the small test specimen, increasing the set-point temperature from T_{S1} and T_{S2} reduces the runaway temperature from T_b to T_c . The large test specimen at setpoint T_{S2} is on the verge of giving a runaway reaction.

Figure 11. Principle heat production (Equation (1), red line) and heat loss (Equation (2), blue lines) as a function of temperature for a small (solid blue line) and a big (dashed blue line) test specimen, respectively.

If the set-point temperature had been slightly higher than T_{S2} in Figure 11, a runaway reaction would, at least theoretically, be expected. An experiment was therefore conducted with set-point temperature at 205 °C to further investigate this phenomenon, as seen in Figure 12. When the test specimen center temperature reached about 200 °C, an immediate runaway reaction was experienced, increasing the temperatures to above 600 °C. Whether this resulted in flaming combustion was, however, not known as the muffle oven was not equipped with a window for visual inspection during testing.

Based on the theoretical considerations and expressions in Equations (1) and (2), as principally analyzed in Figure 11 and practically demonstrated in Figure 12, it was clear that testing large volumes at higher temperatures would likely give a lower set-point temperature for potential self-heating runaway reactions than observed in the small-scale tests. It was therefore decided to pursue tests involving full-scale filter cassettes, i.e., about 60 cm × 60 cm × 55 cm (depth). It was also decided that these tests should allow for visual inspection since it was important to investigate whether any self-heating would result in a slow or rapid transition to flaming combustion. Any transition to flaming combustion was assumed to represent a fire strong enough to result in hot oil heat exchanger loss of containment and thus involve the hot oil in the fire, as indicated in Figure 3.

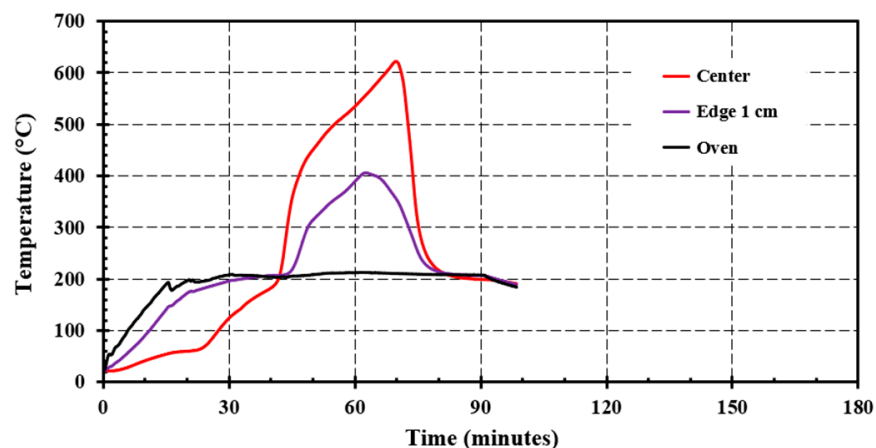
Figure 12. Temperatures recorded in used filters, 10 K/minute heating rate and setpoint 205 °C, resulting in an early runaway reaction.

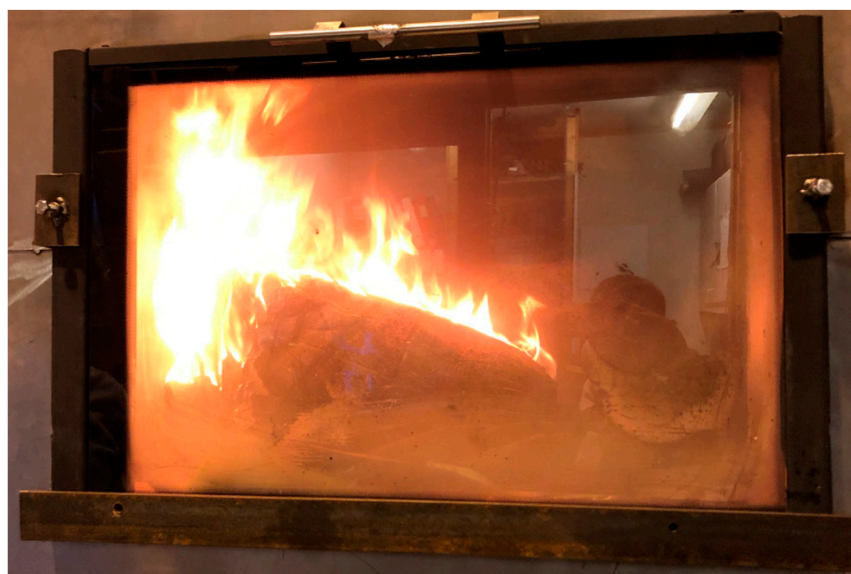
Figure 13. Used filter bag cassette tested at 200 °C. Photo taken 4–5 s after a rapid transition to flaming combustion.

The set-point temperature of the first test was 200 °C. During the heating, the filter cassette tipped over and covered the thermocouple used for the temperature regulation. The thermocouple used to record the local ambient temperature had to be used as a control thermocouple. Therefore, no full data were monitored for this test. However, even before the temperature had stabilized, smoke was released: 2–3 s after a conspicuous increase in smoke production, two local smoke plumes at opposite sides of the filter cassette simultaneously ignited. The flaming combustion spread over the filter, which was fully engaged in flaming combustion 4–5 s after the transition to flaming combustion, as seen in Figure 13.

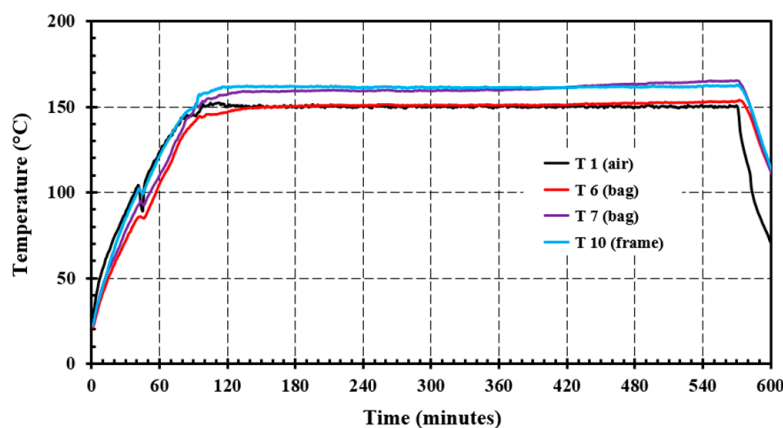
To further investigate possible self-heating of used filter cassettes at lower temperatures, a test with set-point temperature at 150 °C was undertaken; see Figure 15. Self-heating to 14–15 °C above the local ambient temperature was observed, with an increasing trend after a 7–8-h incubation period. Unfortunately, that test had to be terminated due to the late hours for a test requiring supervision.

Figure 15. Used coarse filter bag cassette tested at 150 °C.

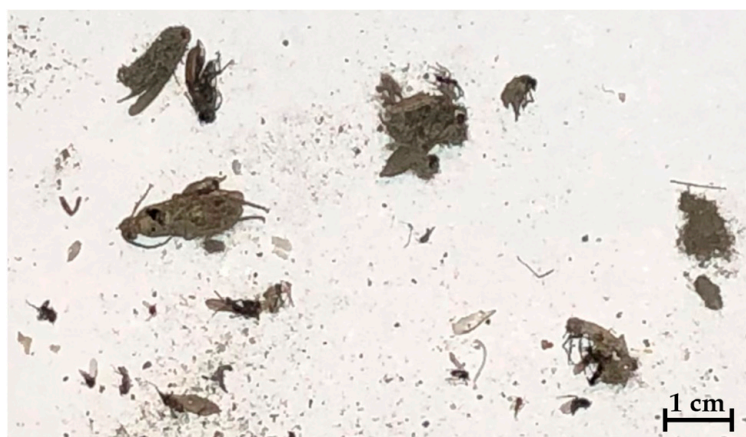
A clue to why used coarse filters self-ignited at lower temperatures than new filters is shown in Figure 16. The used filters contained accumulated pterygota. Investigating the fraction of pterygote and other hygroscopic, e.g., plant-based materials, was not undertaken as part of the present study. Based on the time delay in the temperature increase, along with evidence as presented in Figure 16, it is suggested that accumulated biomass played a role in self-heating of the filters and that this most likely led to the fire at the LNG plant. However, catching and containing such biomass is indeed an important part of the mission of such filters.

Figure 16. Representative pterygota from a used coarse filter bag.

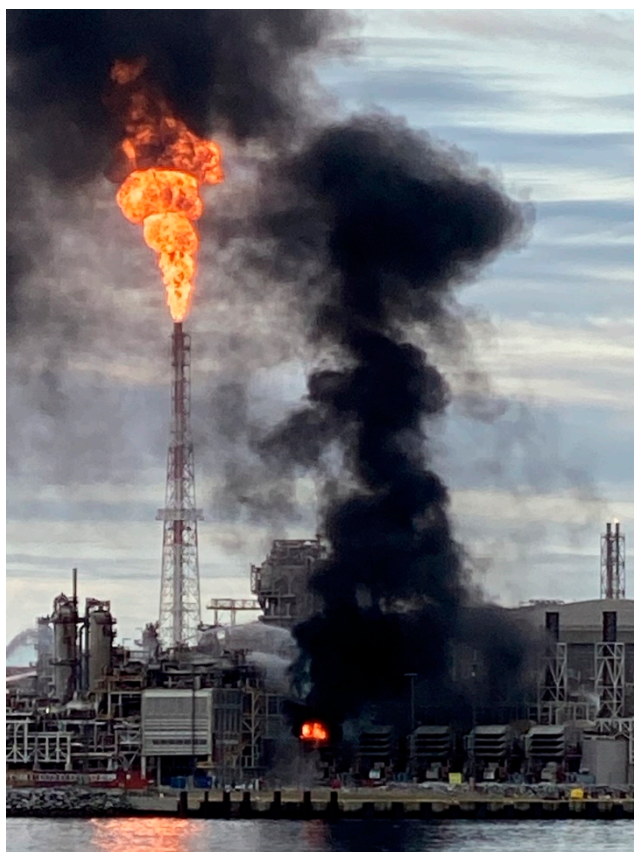
Figure 17. Photo of the GTG 4 air intake fire with the process depressurization flare in the background. Photo by Stein Lyder taken from Sørøysundekspresen. (Reproduced with permission.).

Simple measures could often significantly reduce the consequences of the developing incidents. A temperature alarm being triggered when exceeding the 70 °C design temperature [7] and/or better sharing of knowledge of an air intake filter fire, like the one at, e.g., Petrojarl Knarr FPSO [13,14] in the North Sea, could have prevented the fire at Hammerfest LNG. Sharing incident information may help prevent similar future air intake fires by, e.g., understanding possible self-heating mechanisms and the influence of accumulated biomass, installing warning systems for excessive filter house temperature, improving operation procedures, etc. Improved emergency training in cooperation with the fire brigades [34,35] could also have minimized the consequences of the fire. For further underlying causes of the LNG plant fire ignition mechanism analyzed in the present study, and evaluations regarding the emergency operation, interested readers are referred to the openly shared company investigation report [4] and the PSA report [5].
