## ING5002D - Master Thesis

# **Assessing the Efficacy of Open-State Cavity Barriers with improper installation through intermediate-scale testing**

Master Thesis in Fire Safety Engineering

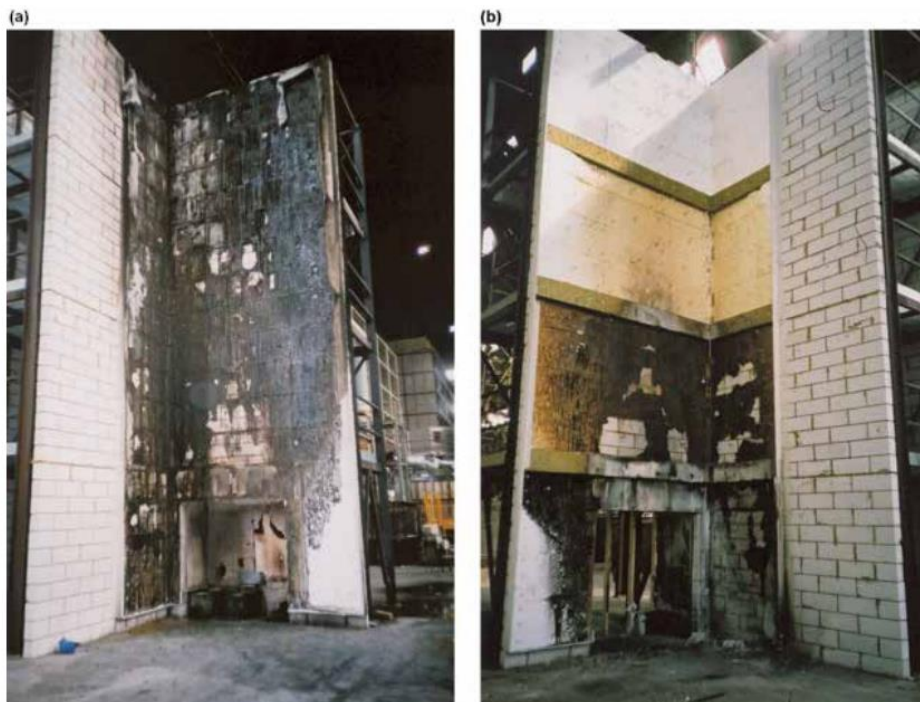
Figure 4 - (a) EPS system without fire barriers (b) EPS system with Fire Barriers - Source: BR135:2013

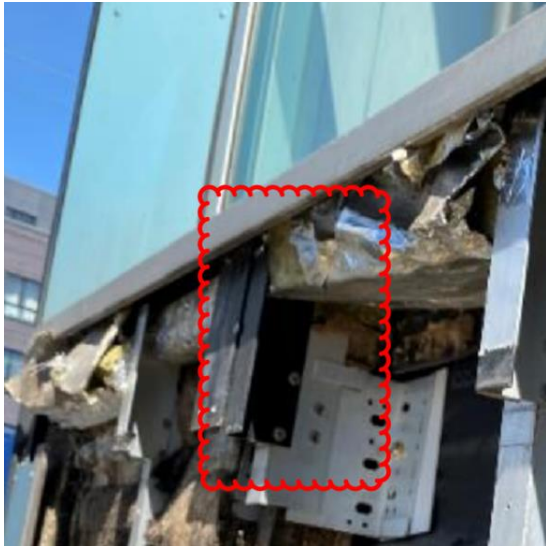
*Figure 10 - Loosely packed cavity barriers with blockages in front of the intumescent strip highlighted in red cloud*

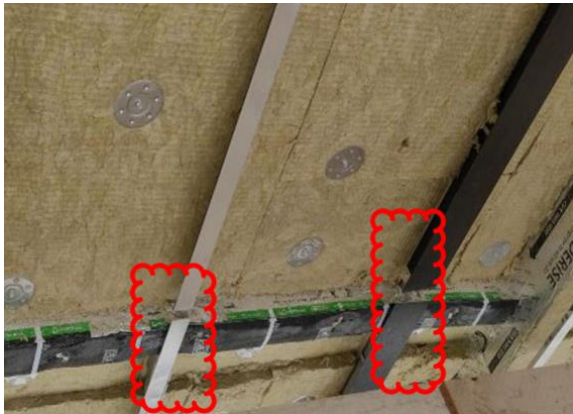
*Figure 11 - Blockages in front of the cavity barrier highlighted in red colour*

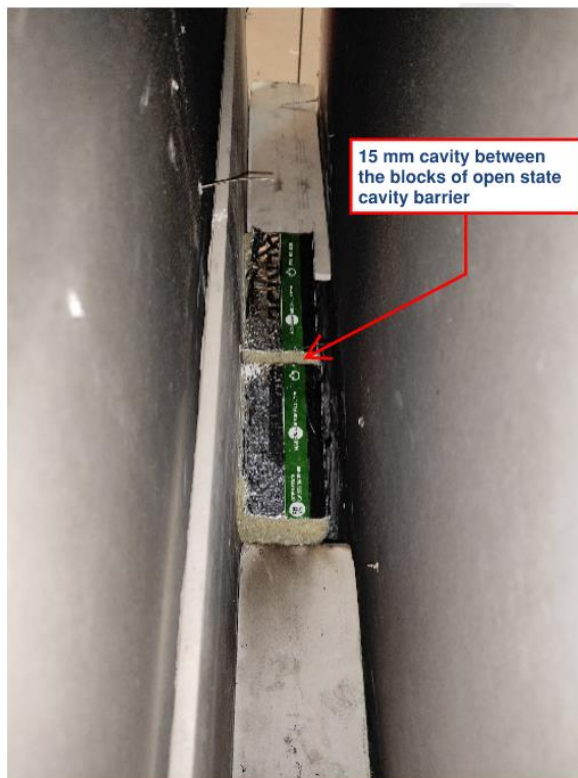
Figure 24 –The OSCB blocks installed within the experimental setup with a gap in between.

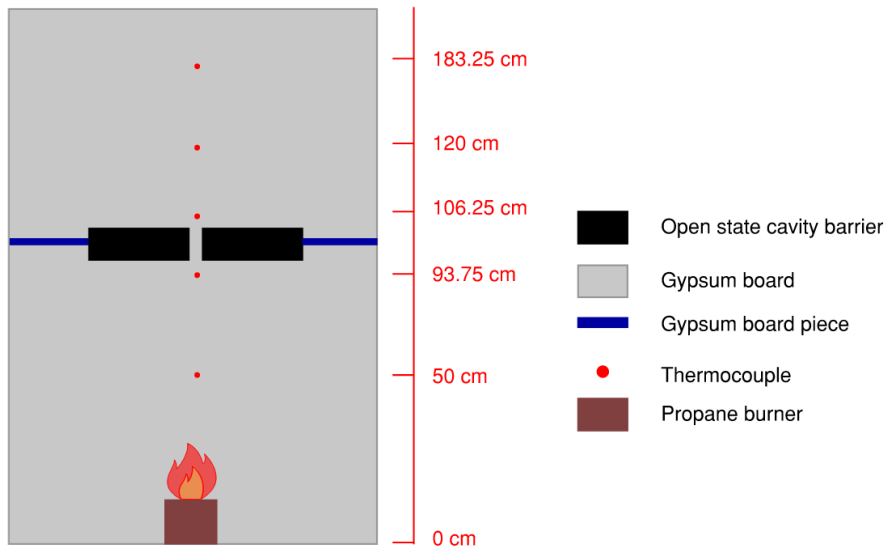
heights were precisely set at 50 cm, 93 cm, 106 cm, 120 cm, and 183 cm measured from the base of the cubic propane burner.

Figure 25 –Front view section of the experimental setup for Scenario 2, 3 and 4.

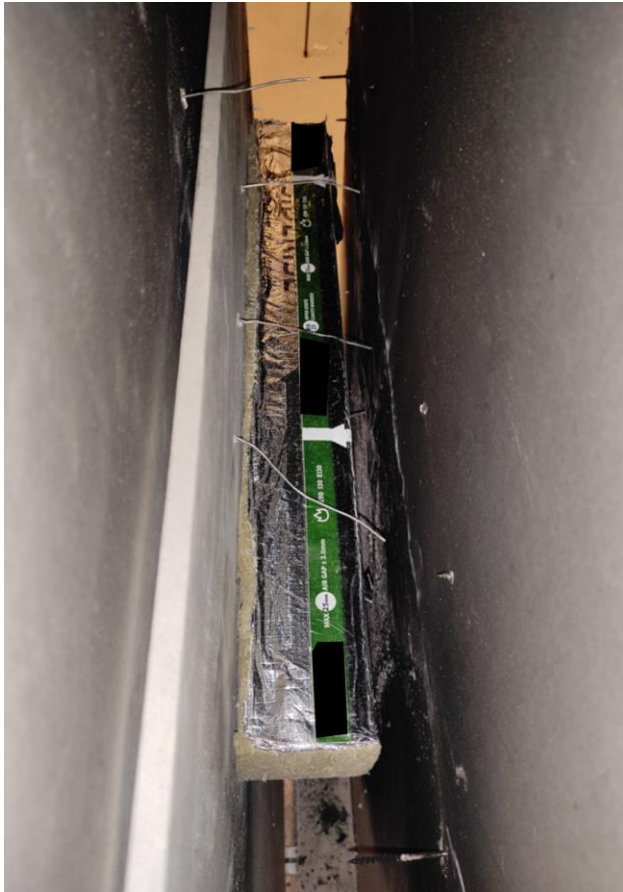
Figure 35 –The cavity barrier blocks installed for the scenario 6.

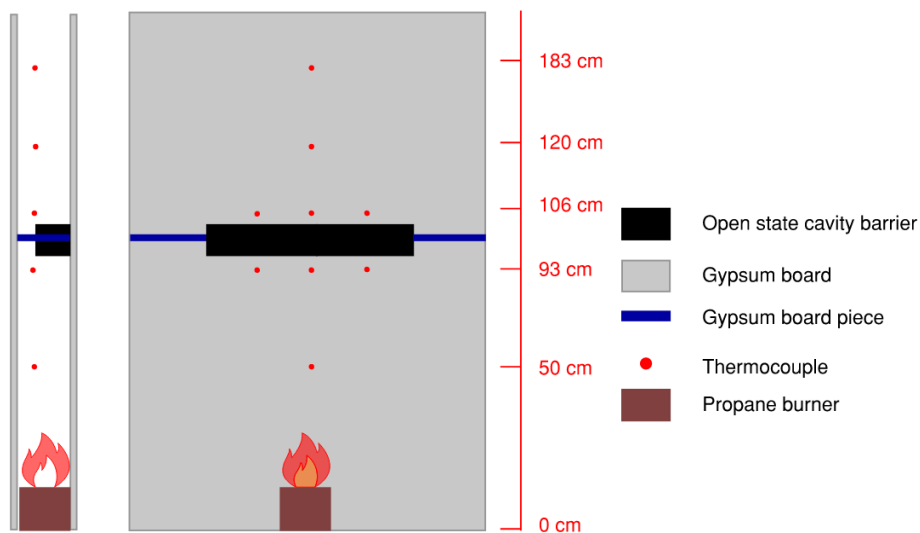
The experimental configuration, as depicted in Figure 36, featured nine strategically placed thermocouples at varying heights. These thermocouples were located at 50 cm, 93 cm, 106 cm, 120 cm, and 183 cm, each measured from the base of the cubic propane burner. These thermocouples were strategically positioned to monitor temperature fluctuations at precise elevations within the experimental setup.

Figure 36 –Side view and front view of the experimental setup for Scenario 6.

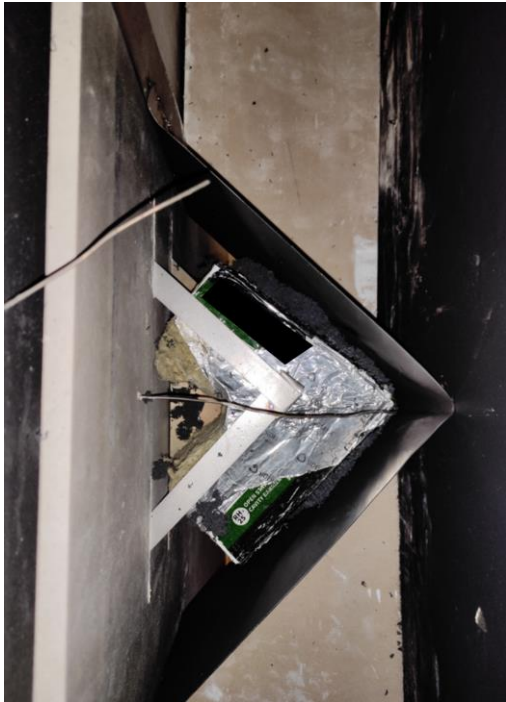
Figure 41 –The installed cavity barrier for the scenario 7.

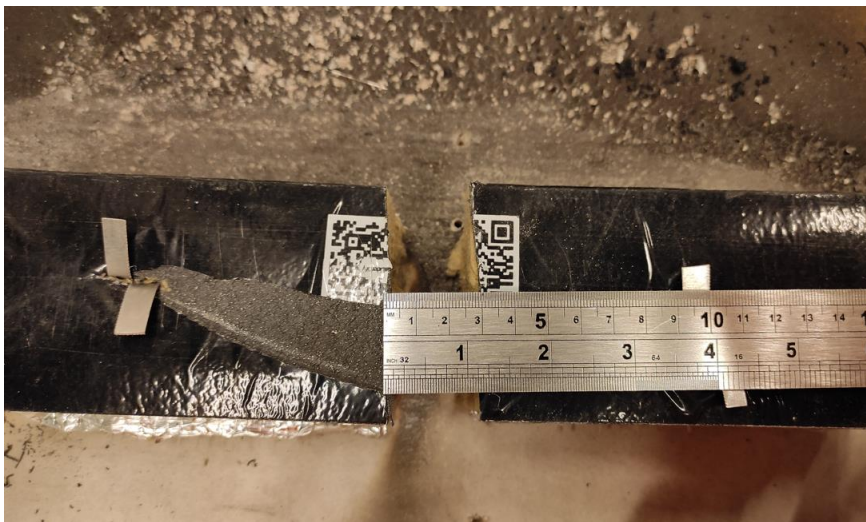
Figure 53 - Cavity barrier blocks installed over the gypsum board keeping a gap of 30 mm.

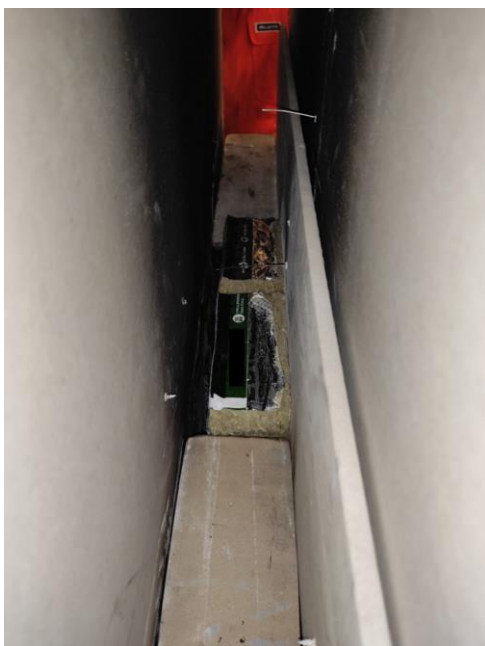
Figure 54 -Cavity barrier blocks installed within the experimental setup with a gap in between.

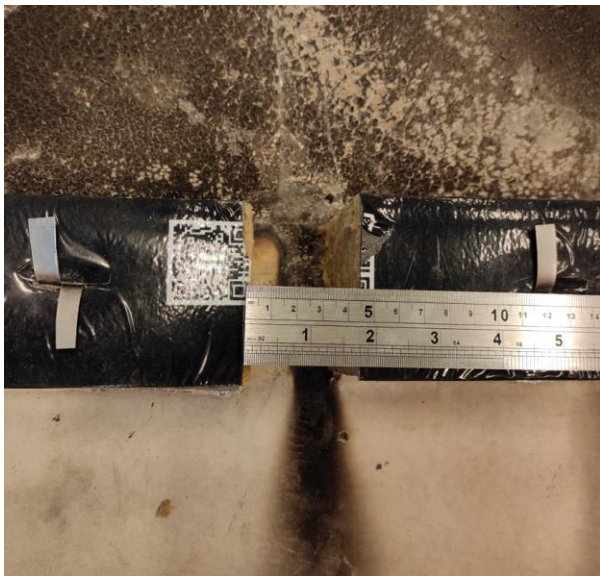
Figure 60 - Cavity barrier blocks installed over the gypsum board keeping a gap of 45 mm.

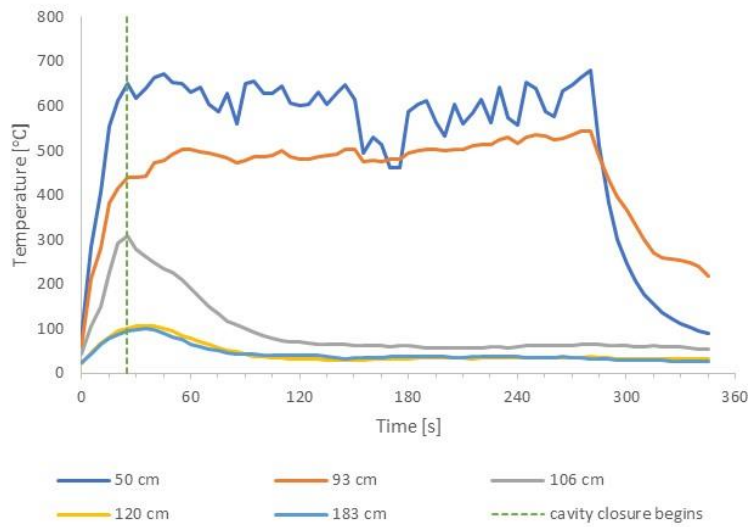
Figure 69 - Thermocouple reading for the experiment with 15 mm gap between the cavity barriers

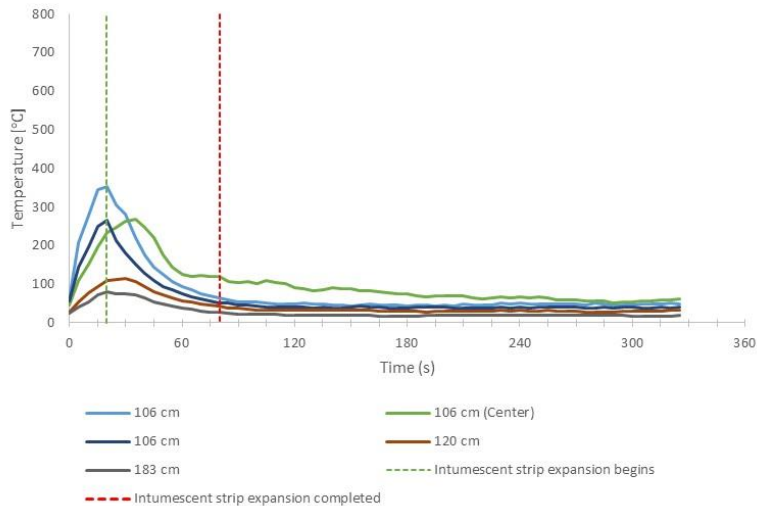
Figure 79 - Beginning and completion of expansion of the intumescent strip in front of the OSCB

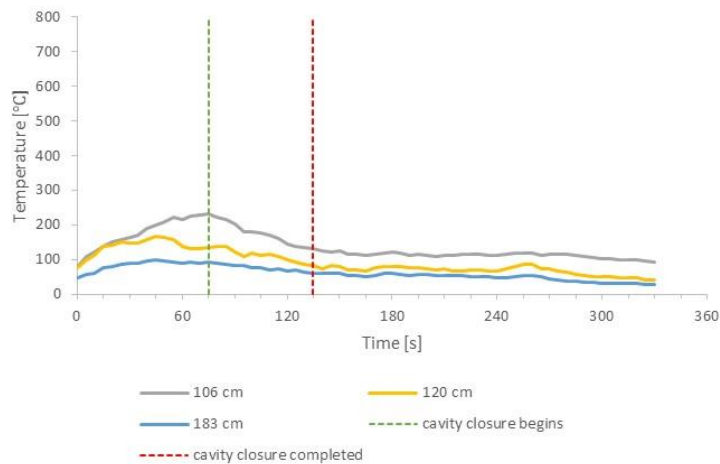
Figure 85 - Beginning and ending of the intumescent strip expansion for zone 2 of the Scenario 7.

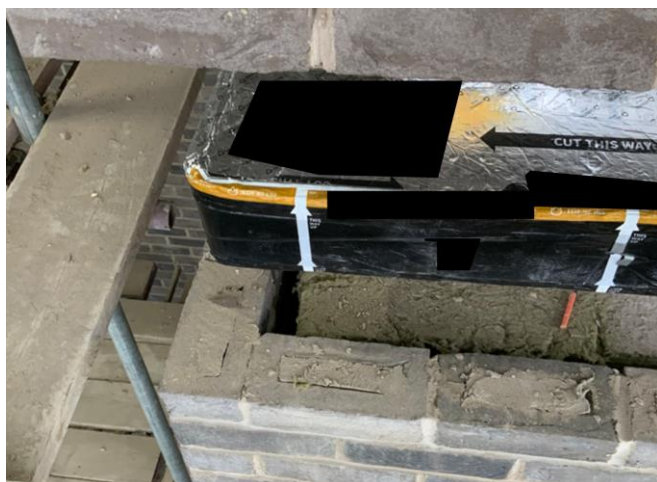
Figure 87 - Deviation from the installation guidelines noticed for the corners
